Uniform Mitigation Verification Inspection Form

Inspection Date: 7/16/2020		
Owner Information		
Owner Name: Lake Clarke Gardens COA, Inc.		Contact Person:
Address: 2811 S. Garden Drive - Bldg #25		Home Phone: (561) 965-8487
City: Lake Worth	Zip: 33401	Work Phone:
County: Palm Beach		Cell Phone:
Insurance Company:		Policy #:
Year of Home: 1971	# of Stories: 3	Email: controller@lakeclarkegardens.com

Elevation Photos

2811 S. Garden Drive - Bldg #25

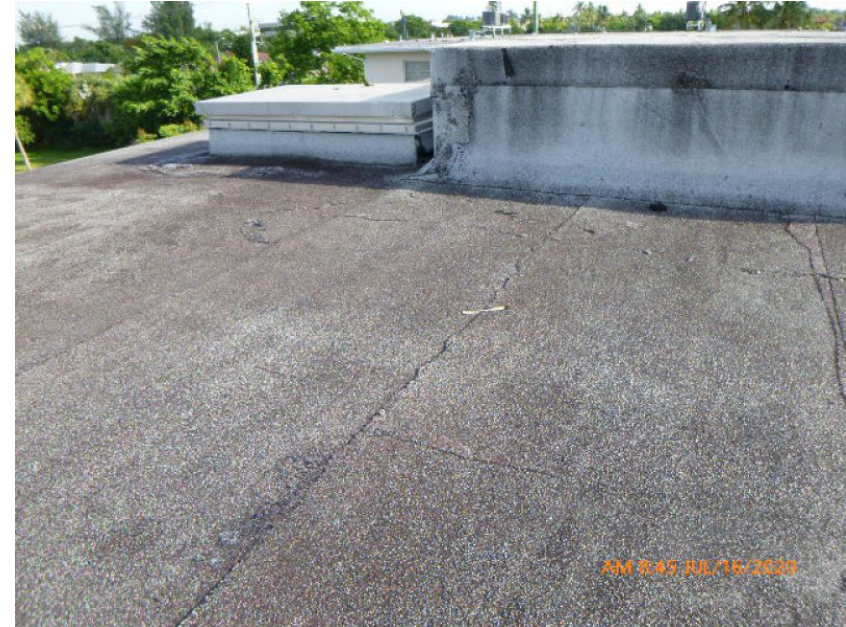
Built-Up/Rolled Asphalt Roof Covering

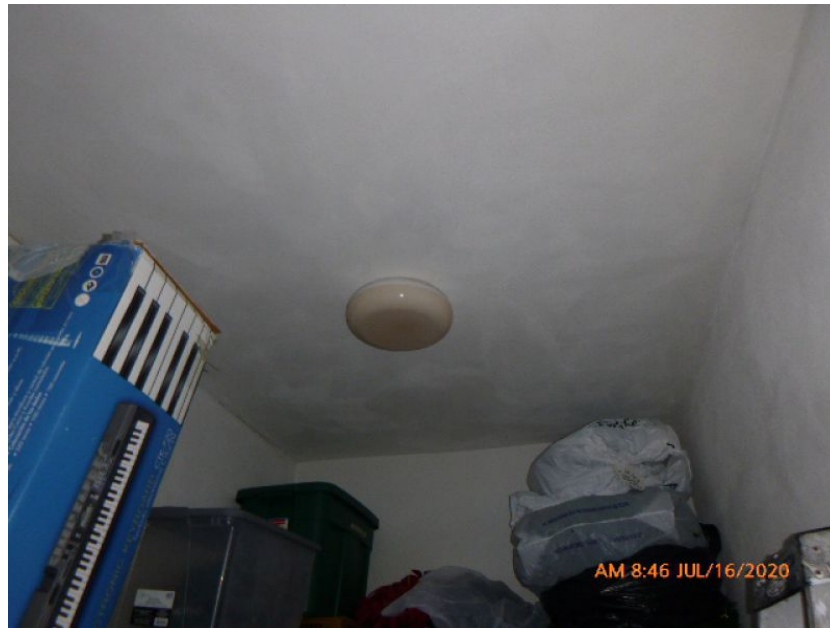
- ☐ D. Reinforced Concrete Roof Deck.
- ☐ E. Other: _____
- ☐ F. Unknown or unidentified.
- ☒ G. No attic access.

- ☐ E. Structural Anchor bolts structurally connected or reinforced concrete roof.
- ☐ F. Other: _____
- ☐ G. Unknown or unidentified
- ☒ H. No attic access

Attachment Unknown due to No Attic Access

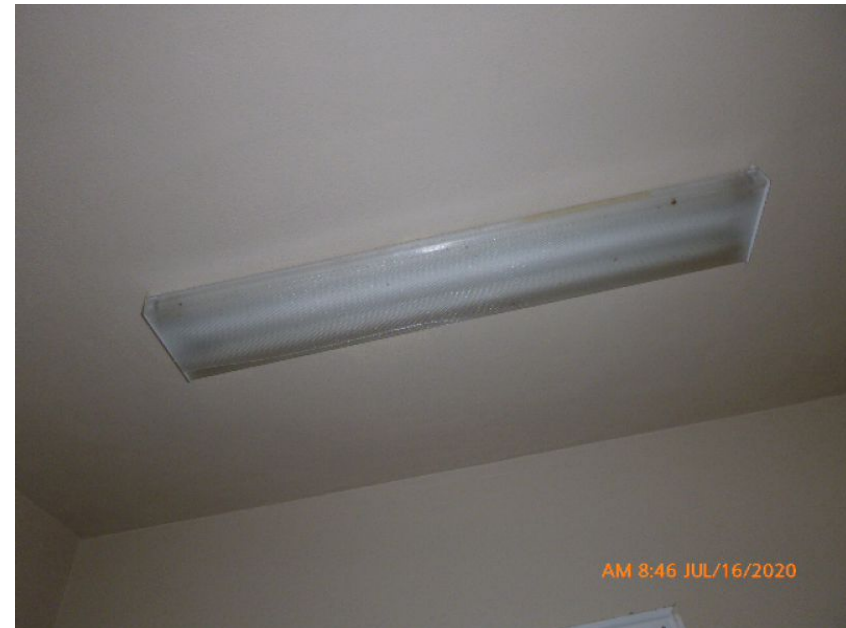
Roof Deck Attachment Unknown

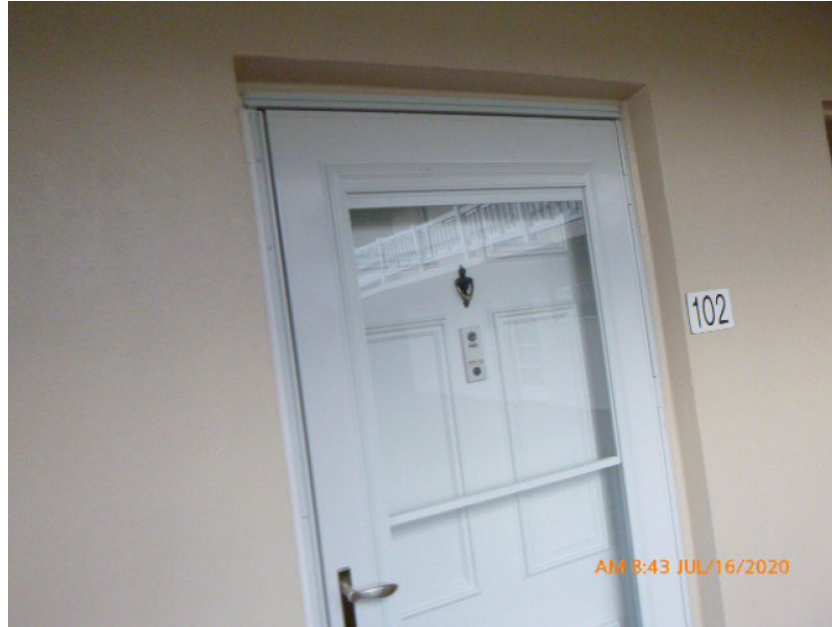
Unprotected Solid Entry Door

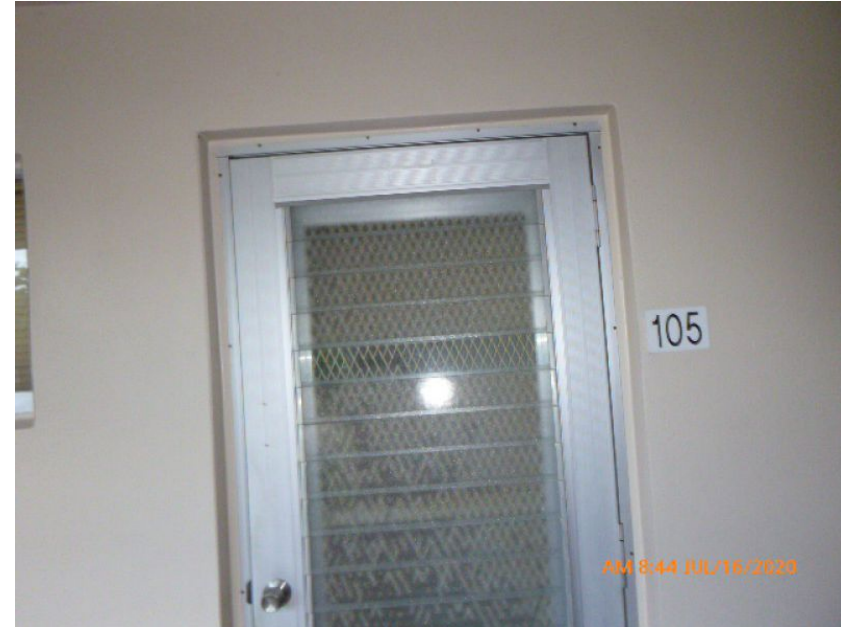
Unprotected Glazed Entry Door

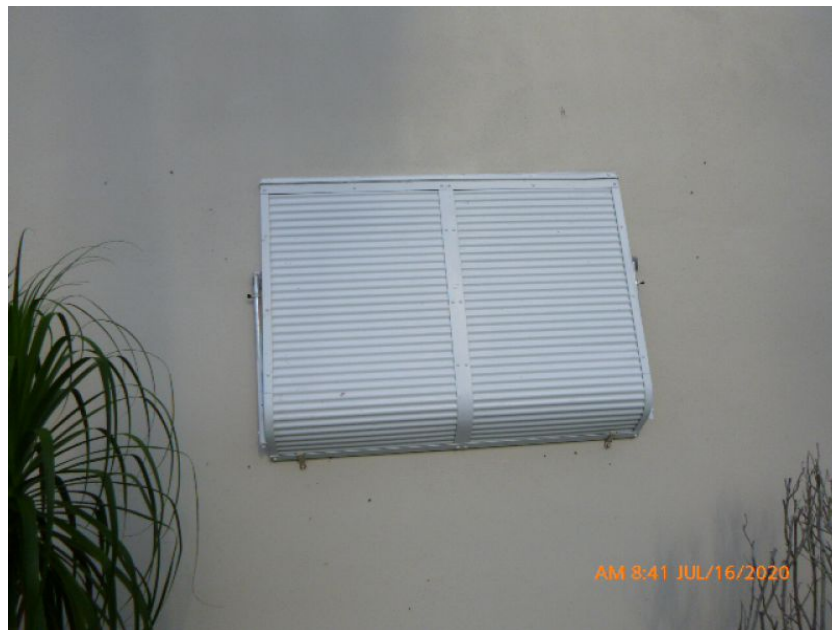
Non-Impact Rated Clamshell Awning Shutter

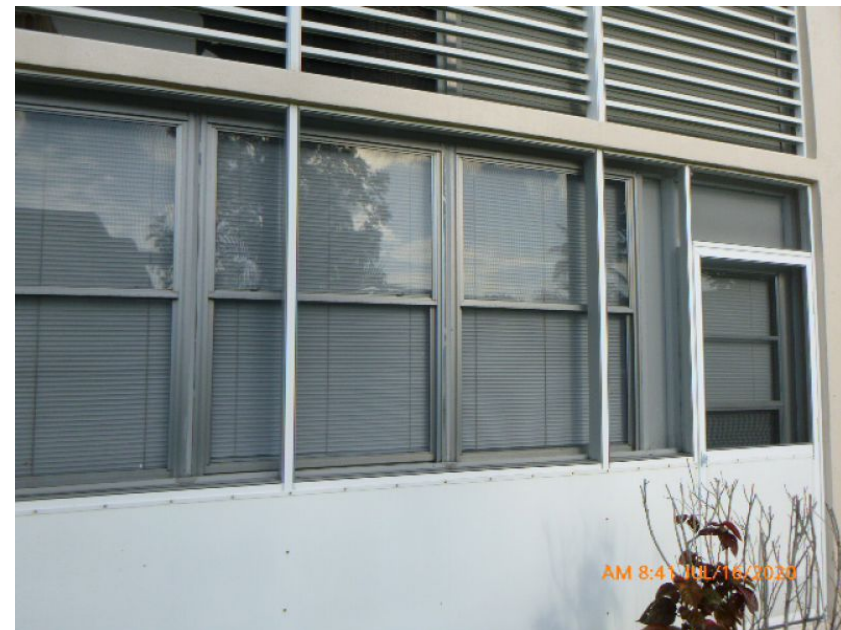
Non-Impact Rated Roll Down Shutter

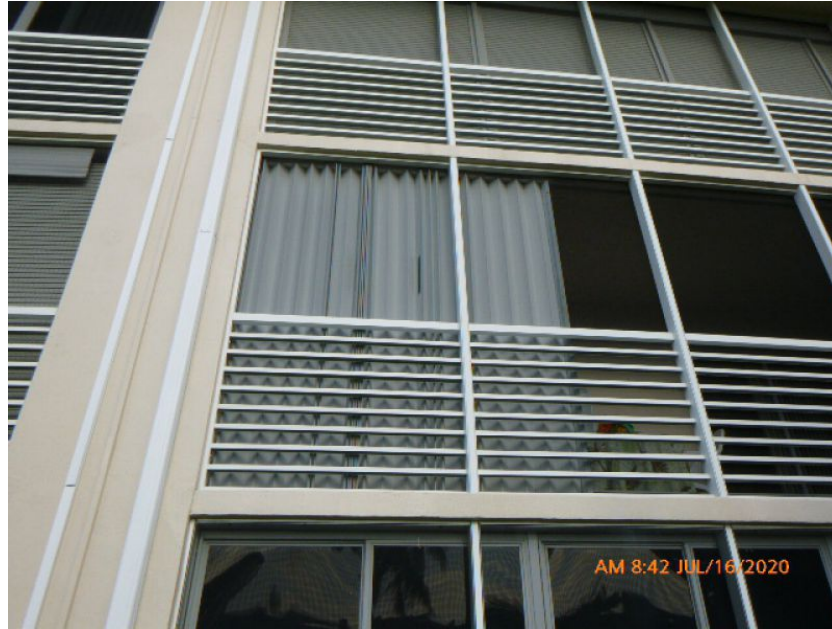
Accordion Shutter - Unverified as Impact

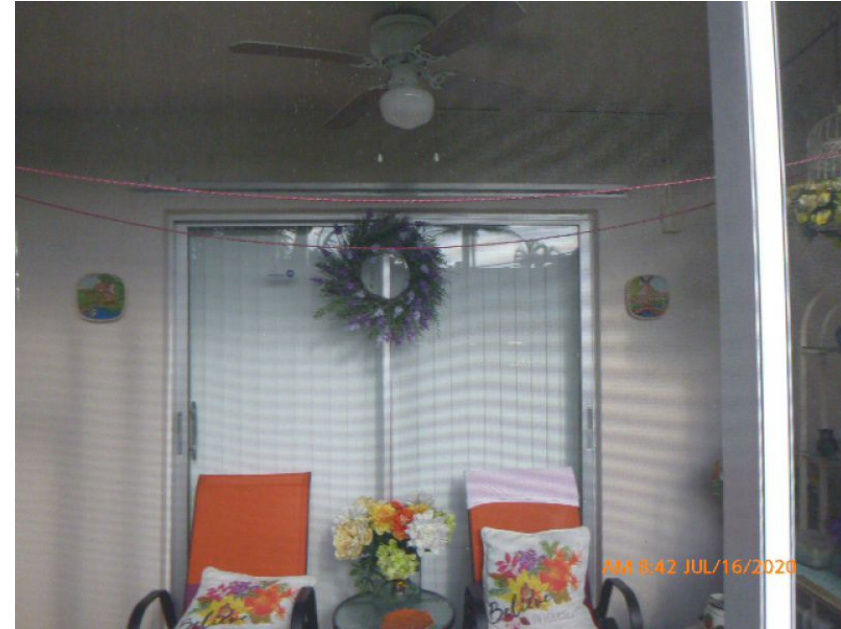
Panel Shutter - Unverified as Impact

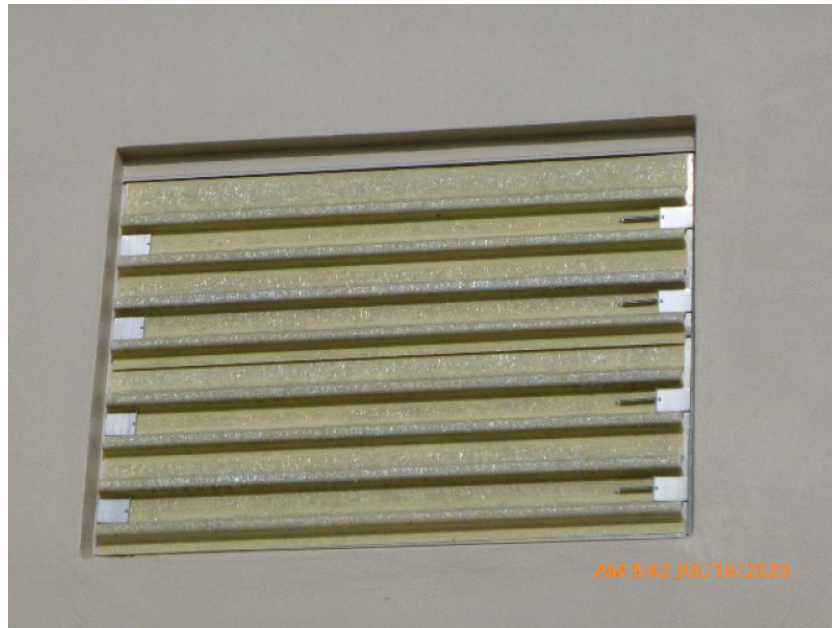
Non-Impact Rated Panel Shutters

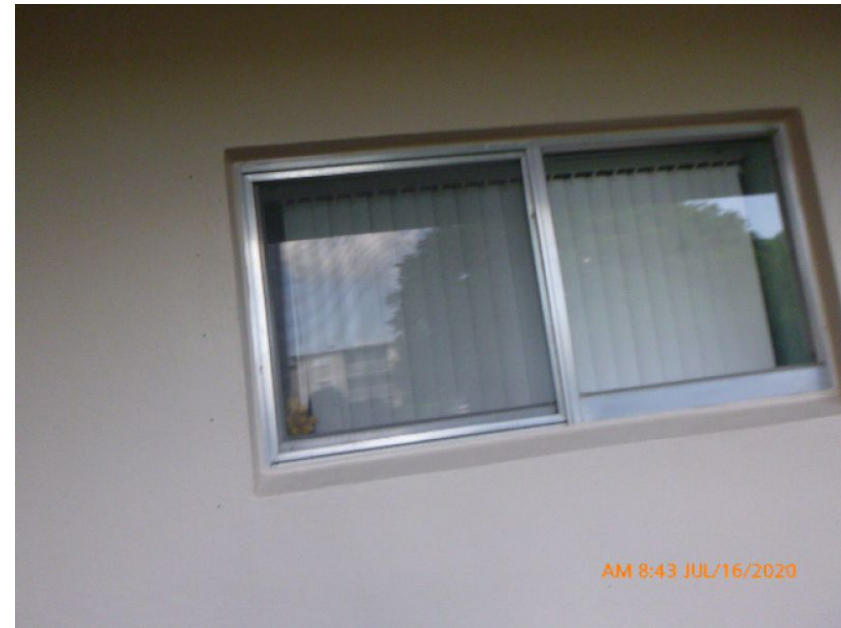
Unprotected Window

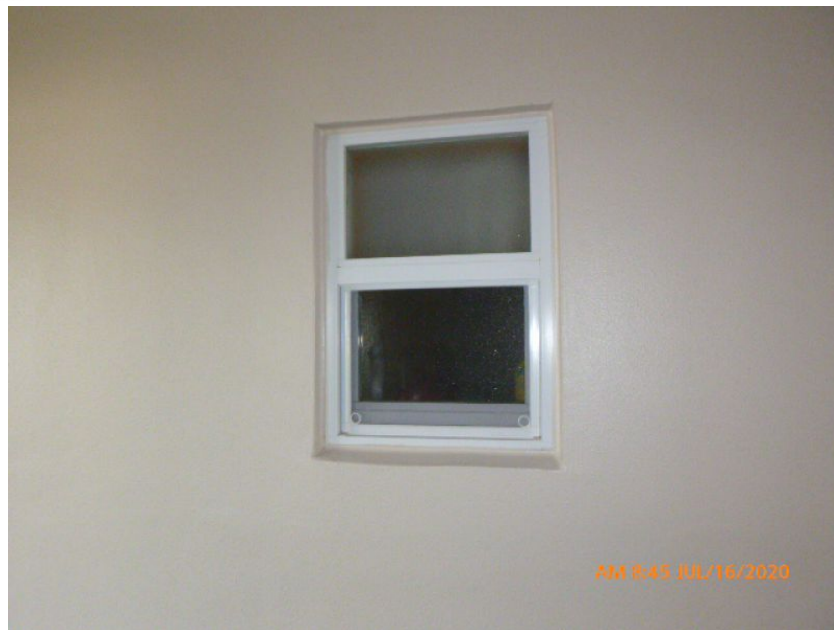
Impact Rated Window

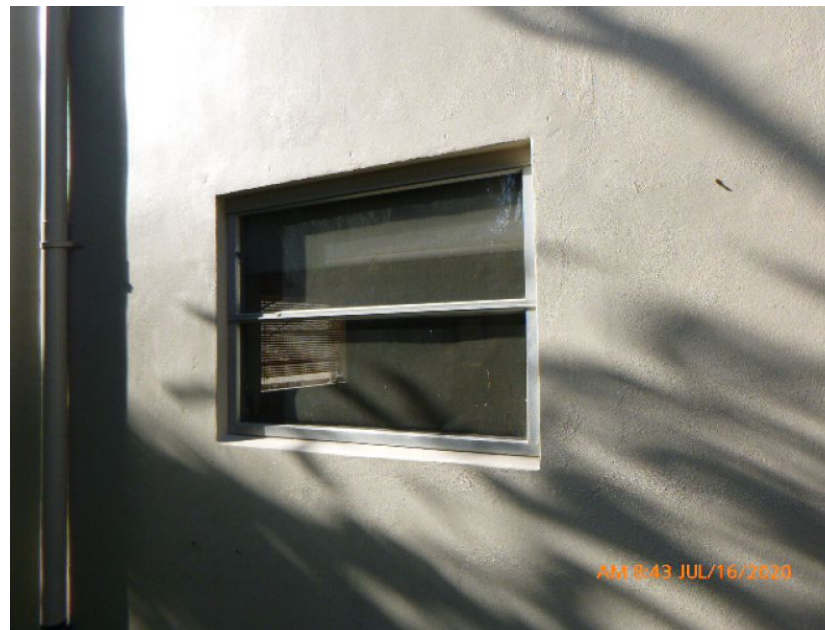
Unprotected Window
