Uniform Mitigation Verification Inspection Form

Inspection Date: 7/16/2020		
Owner Information		
Owner Name: Lake Clarke Gardens COA, Inc.		Contact Person:
Address: 2534 S. Garden Drive - Bldg #20a		Home Phone: (561) 965-8487
City: Lake Worth	Zip: 33401	Work Phone:
County: Palm Beach		Cell Phone:
Insurance Company:		Policy #:
Year of Home: 1970	# of Stories: 2	Email: controller@lakeclarkegardens.com

Elevation Photos

2534 S. Garden Drive - Bldg #20a

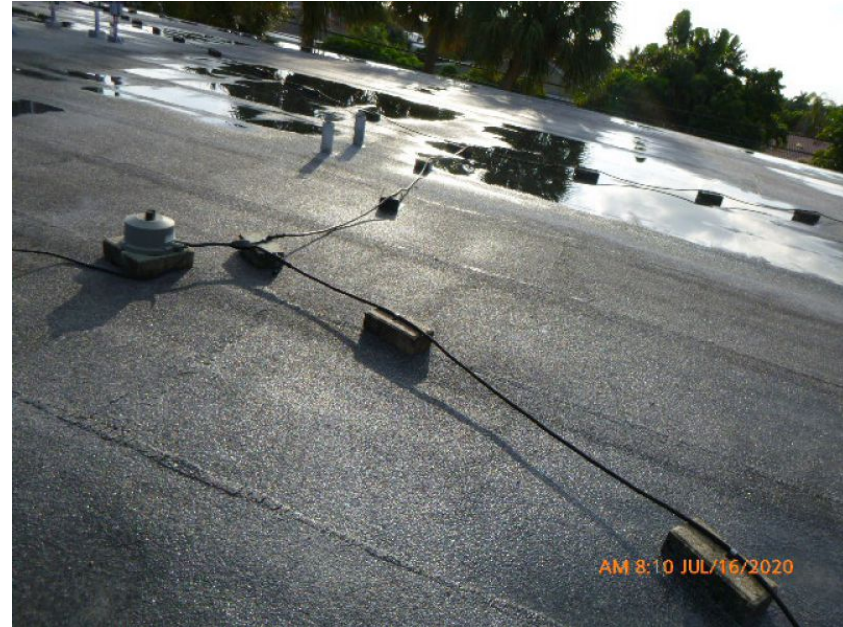
- ☐ A. All roof coverings listed above meet the FBC with a FBC or Miami-Dade Product Approval listing current at time of installation OR have a roofing permit application date on or after 3/1/02 OR the roof is original and built in 2004 or later.
- ☐ B. All roof coverings have a Miami-Dade Product Approval listing current at time of installation OR (for the HVHZ only) a roofing permit application after 9/1/1994 and before 3/1/2002 OR the roof is original and built in 1997 or later.
- ☐ C. One or more roof coverings do not meet the requirements of Answer "A" or "B".
- ☒ D. No roof coverings meet the requirements of Answer "A" or "B".

Built-Up/Rolled Asphalt Roof Covering

Roof Covering Replacement. Our report shows that at least a portion of your roof was permitted prior to the adoption of the latest building codes. As a result, the next time your roof is replaced, it will receive credit for having a roof covering and installation that meets the very latest Florida Building Code requirements.

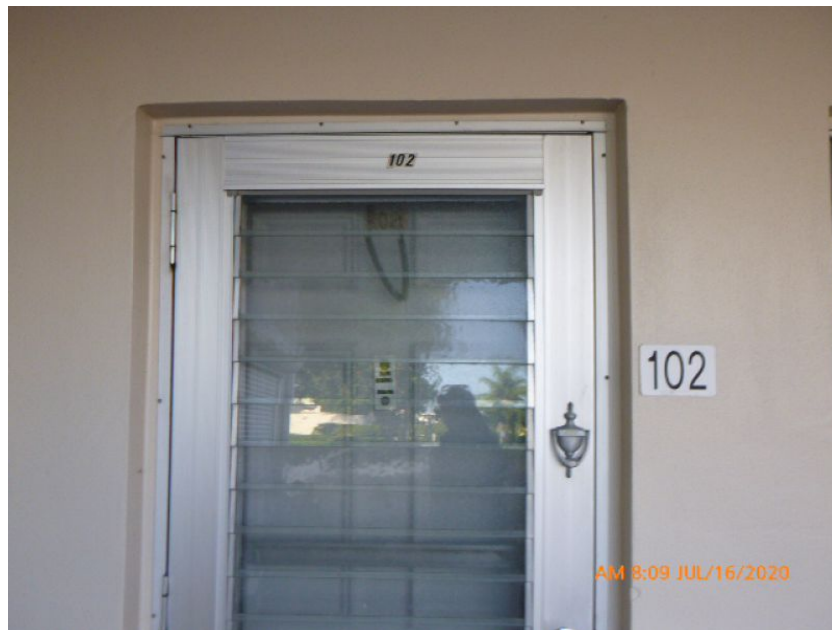
Unprotected Solid Entry Door

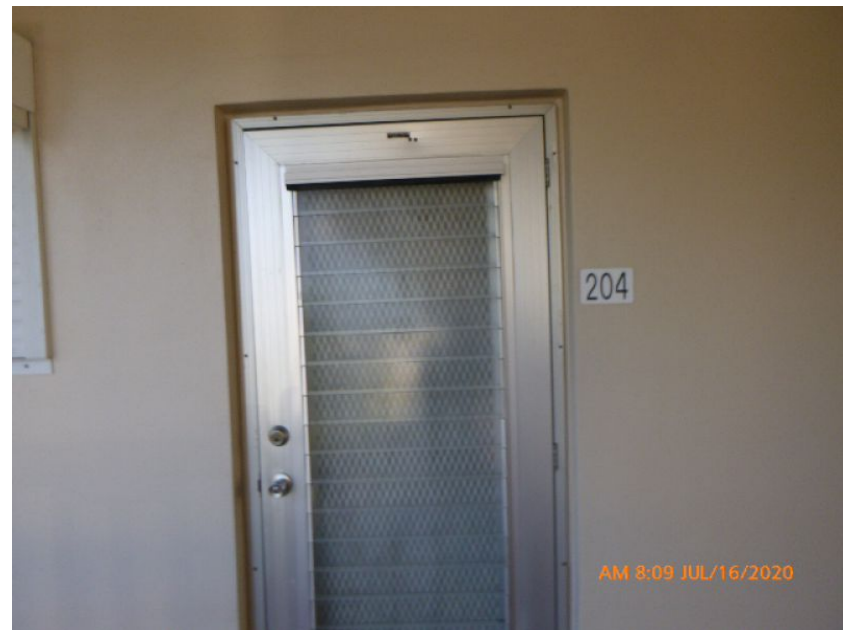
Unprotected Glazed Entry Door

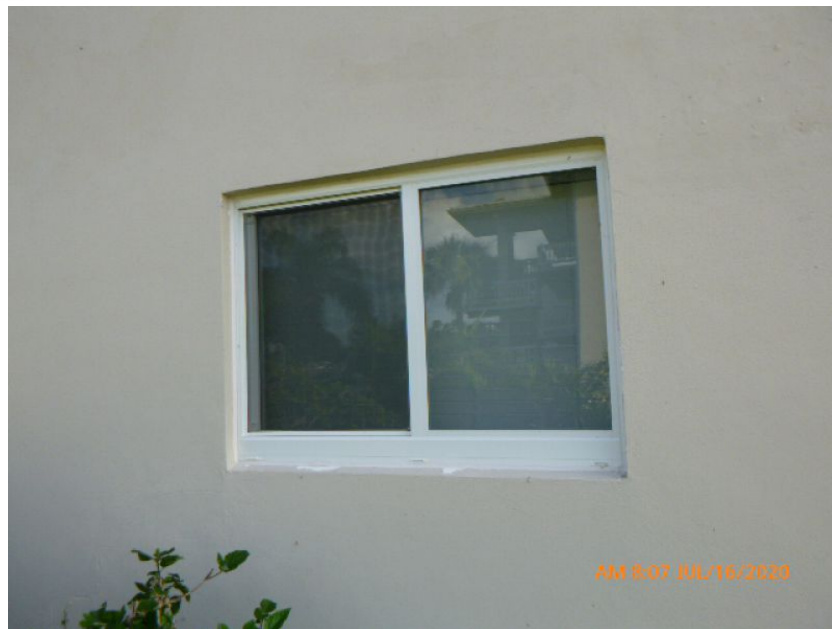
Impact Rated Window

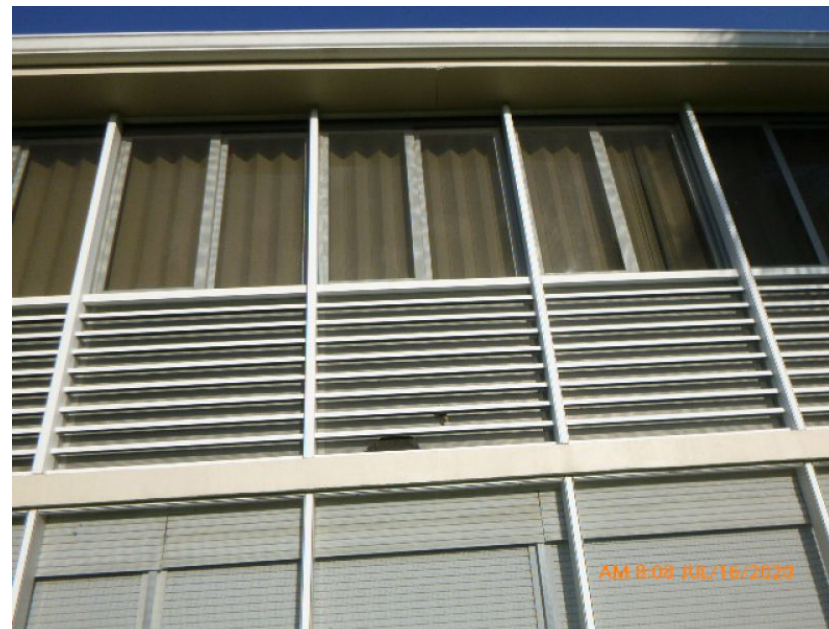
Non-Impact Rated Roll Down Shutter

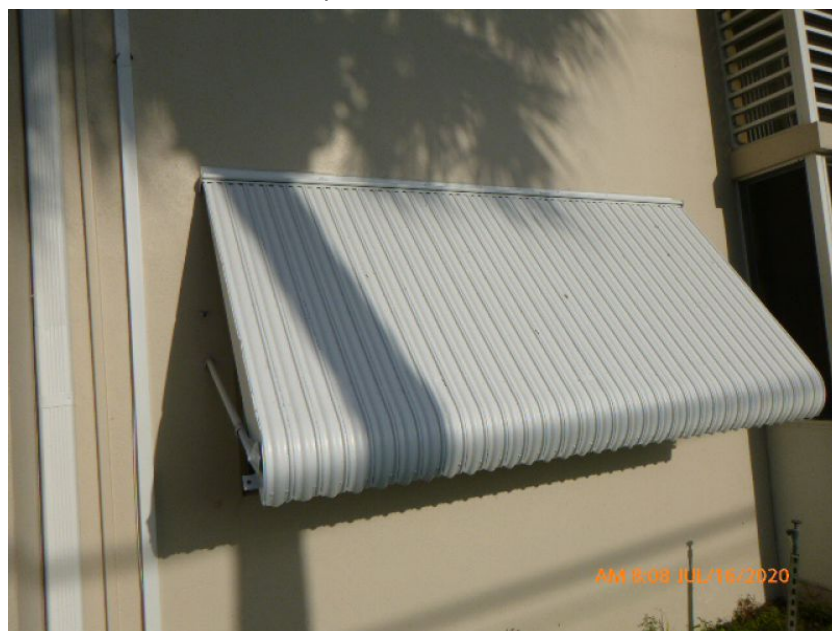
Non-Impact Rated Clamshell Awning Shutter

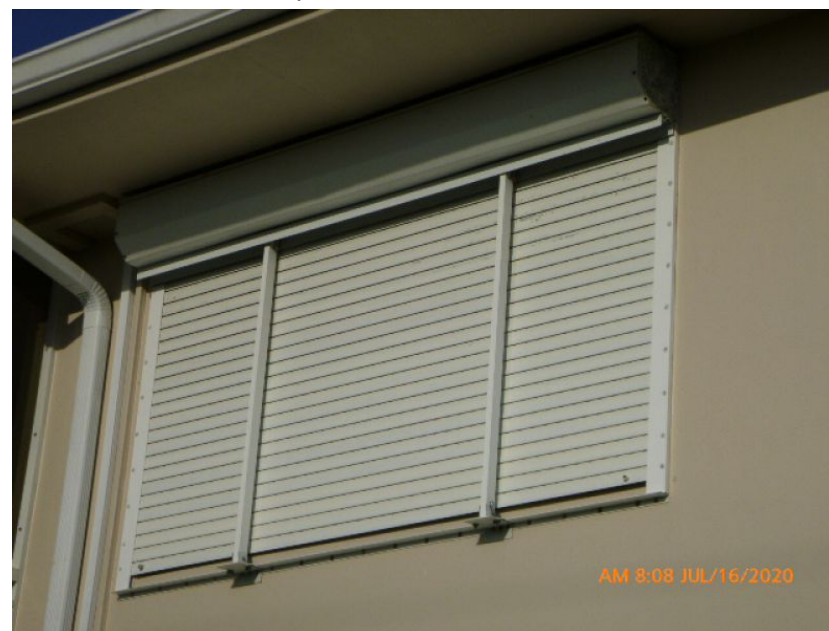
Non-Impact Rated Roll Down Shutter

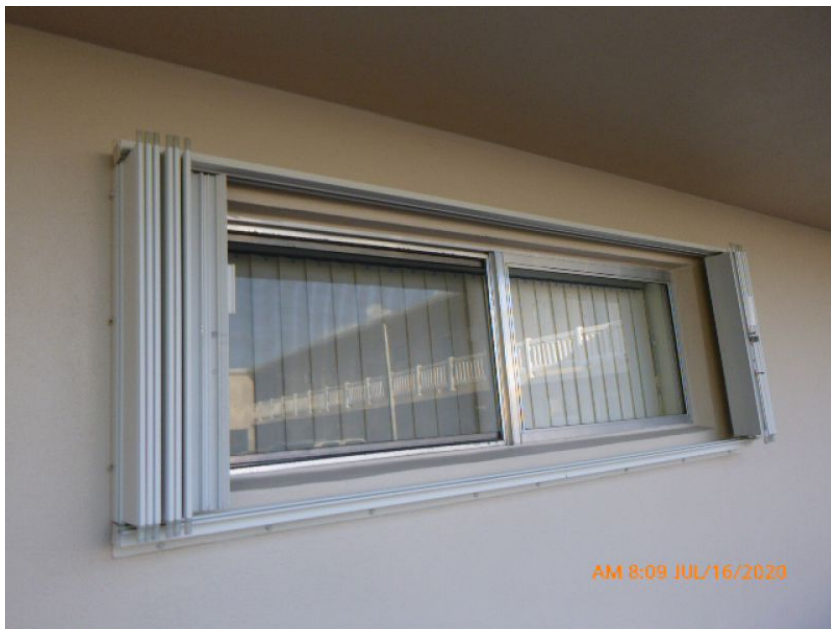
Non-Impact Rated Accordion Shutter

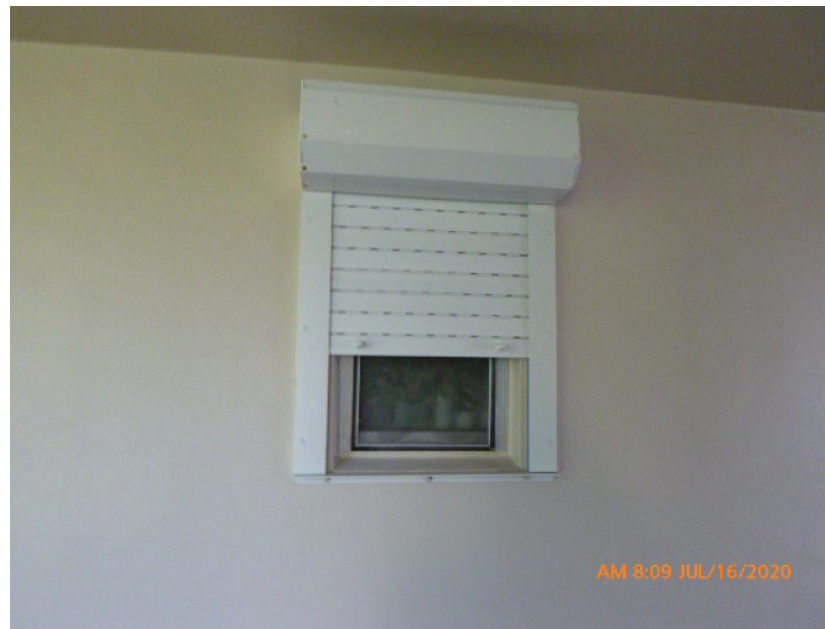
Non-Impact Rated Roll Down Shutter

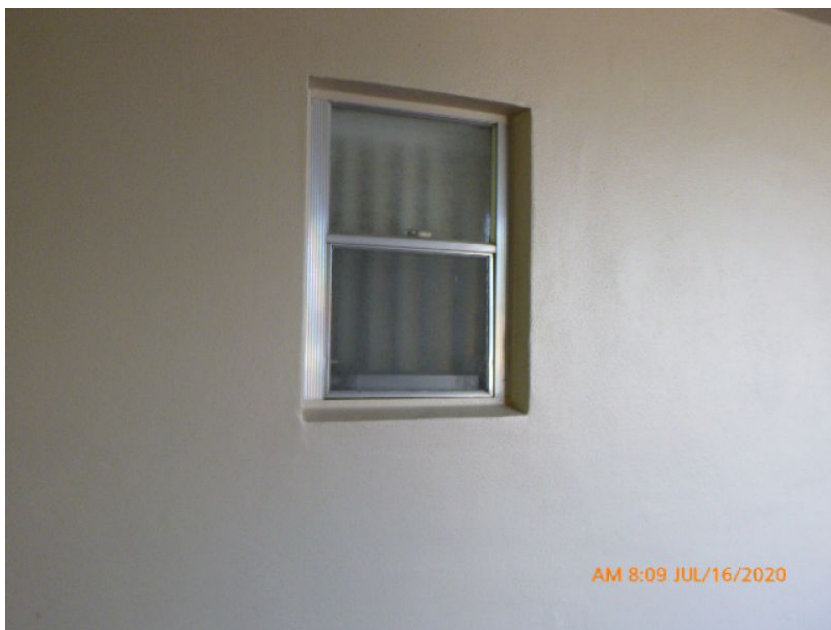
Unprotected Window

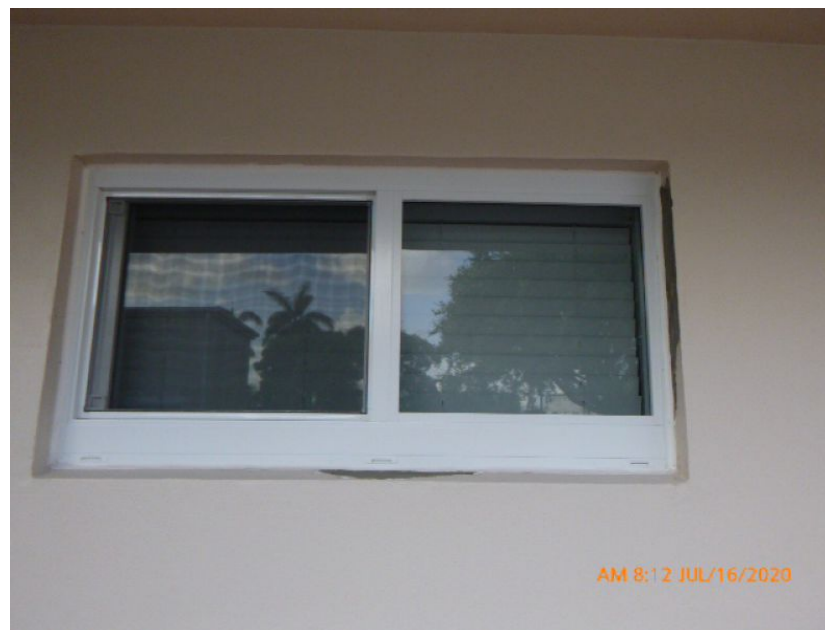
Impact Rated Window

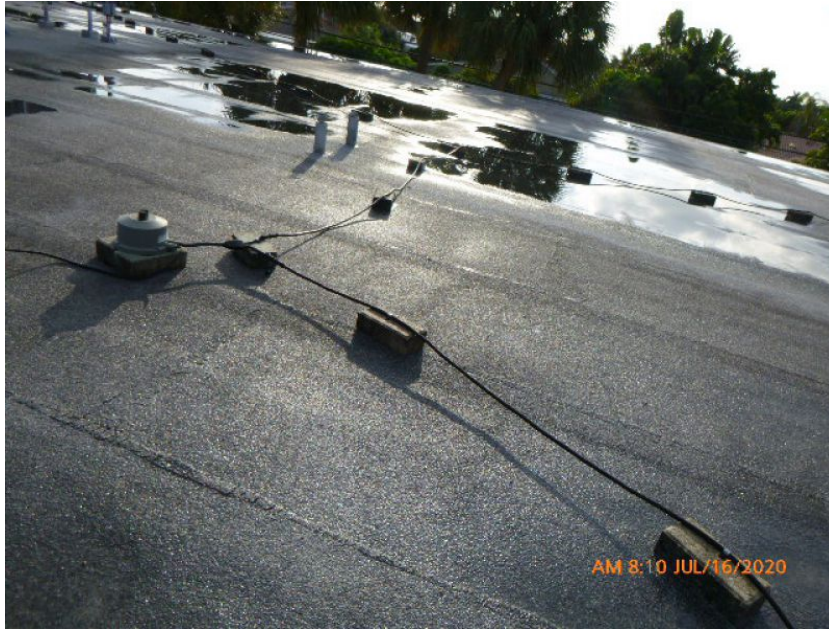
Reinforced Concrete Roof Deck

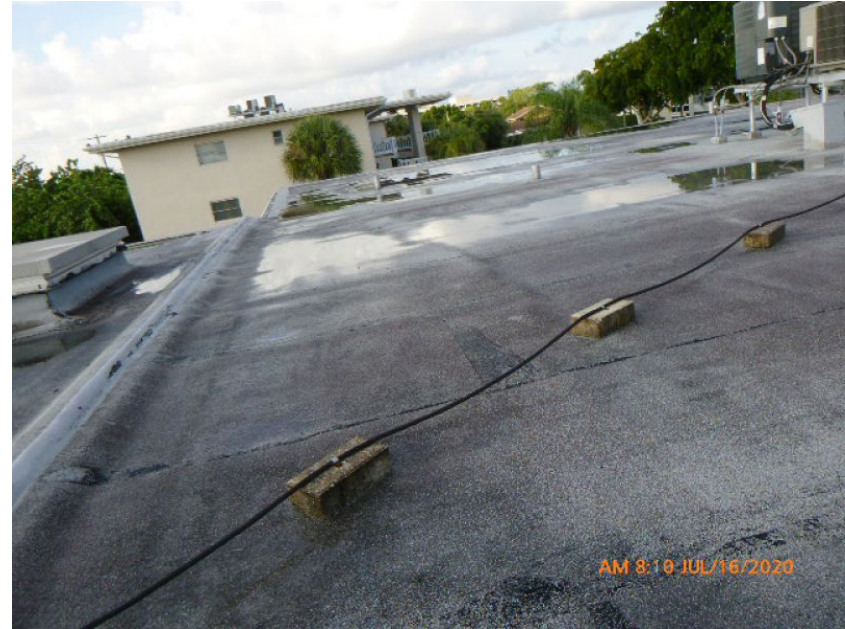
Structural: Reinforced Concrete
