Uniform Mitigation Verification Inspection Form

Inspection Date: 7/15/2020		
Owner Information		
Owner Name: Lake Clarke Gardens COA, Inc.		Contact Person:
Address: 2721 N. Garden Drive - Bldg #6		Home Phone: (561) 965-8487
City: Lake Worth	Zip: 33401	Work Phone:
County: Palm Beach		Cell Phone:
Insurance Company:		Policy #:
Year of Home: 1970	# of Stories: 3	Email: controller@lakeclarkegardens.com

2721 N. Garden Drive - Bldg #6

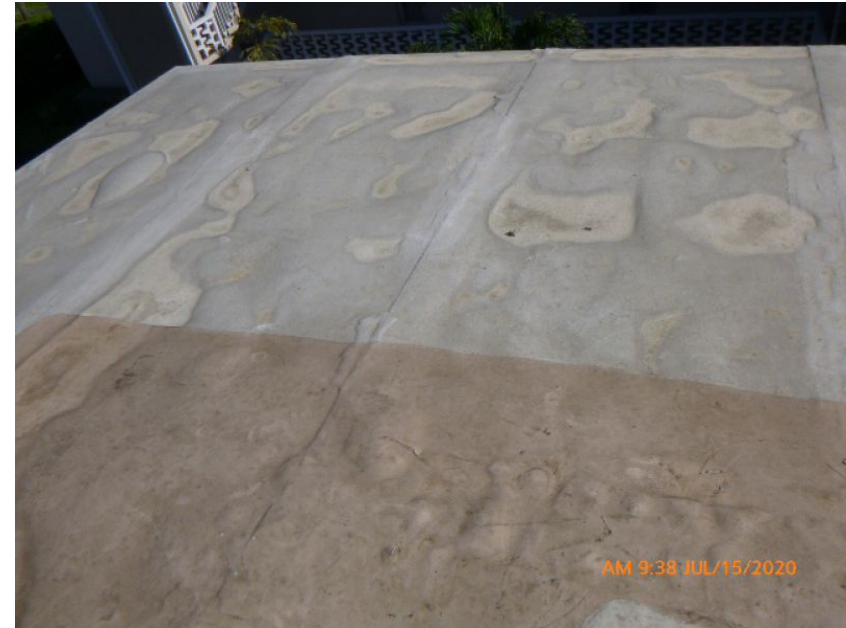
Built-Up/Rolled Asphalt Roof Covering

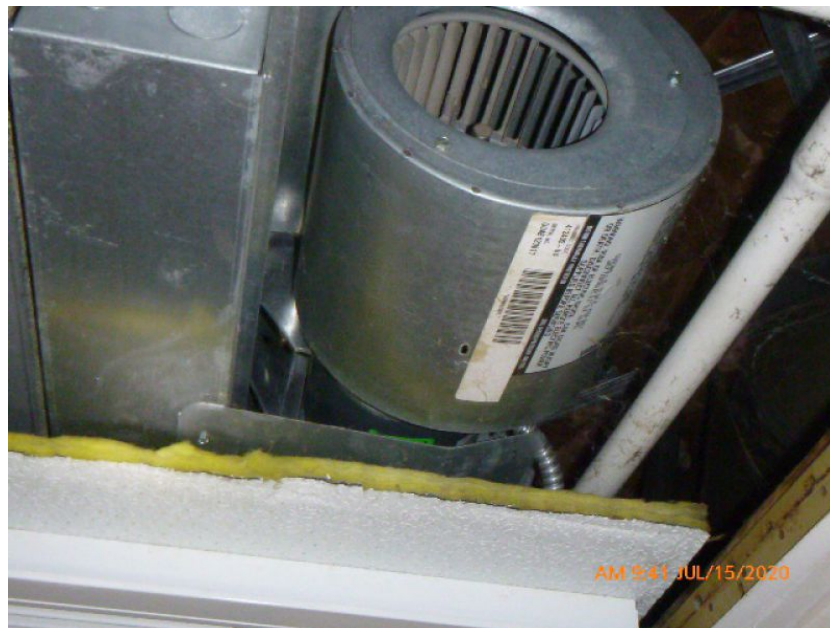
No Attic Access

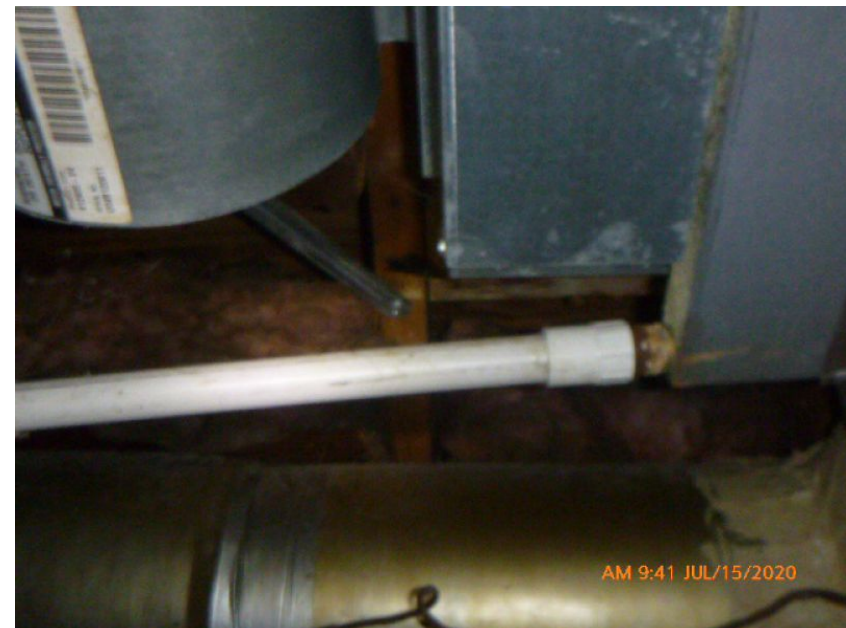
Attachment Unknown due to Insulation

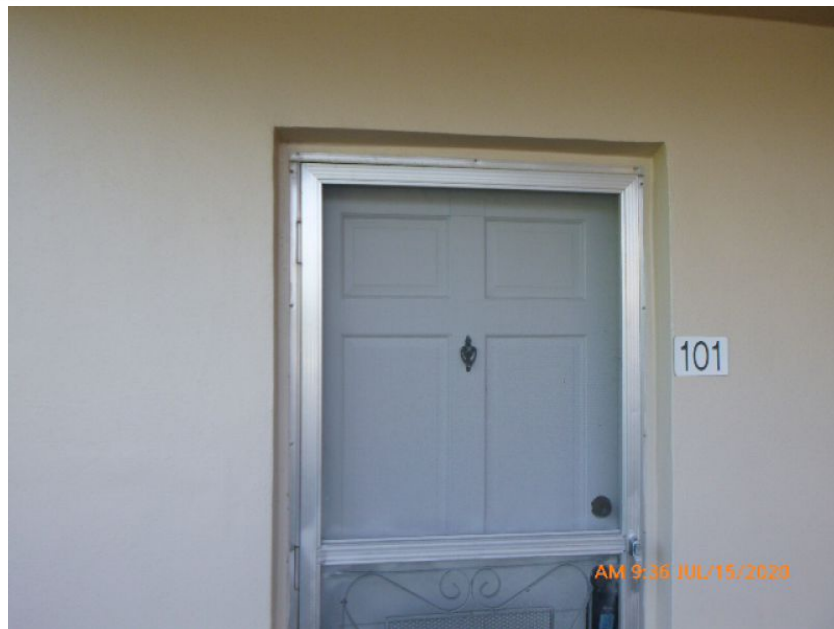
Unprotected Solid Entry Door

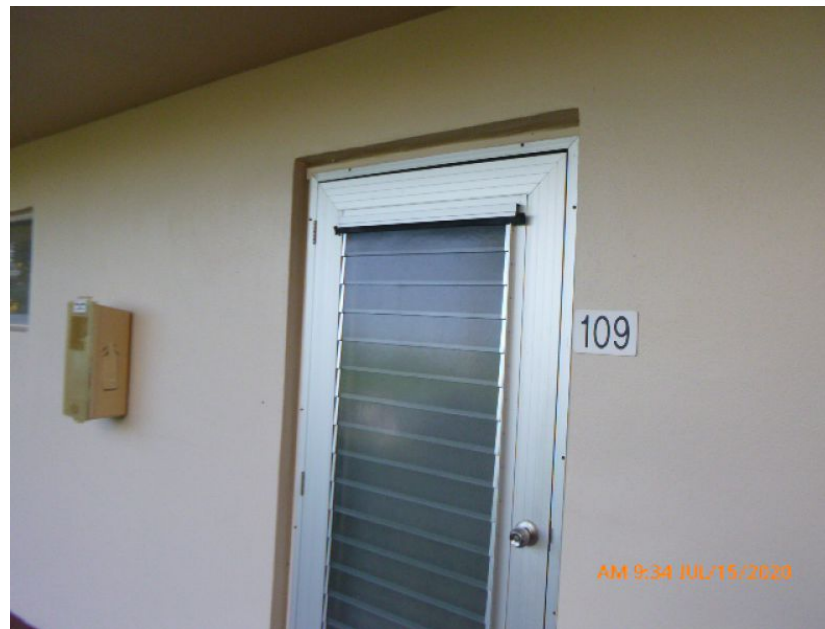
Unprotected Glazed Entry Door

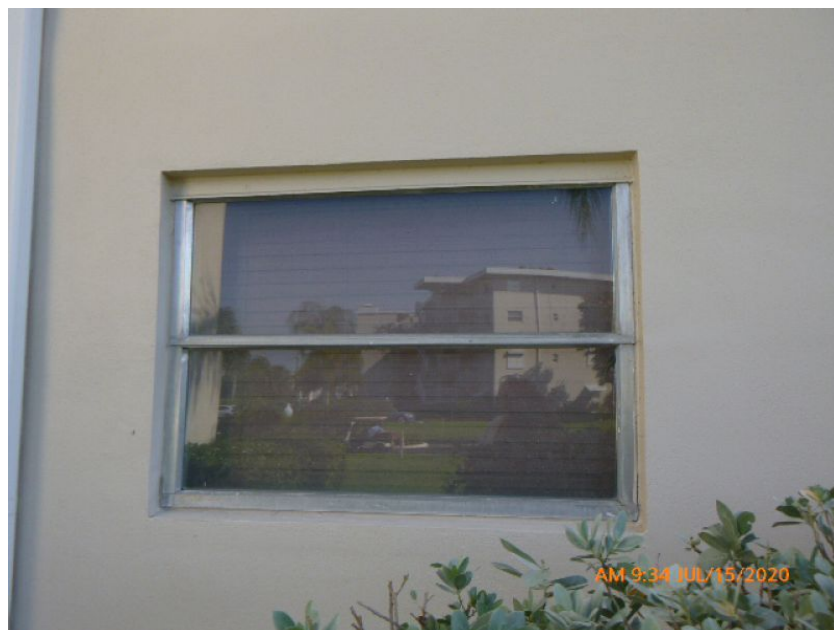
Unprotected Window

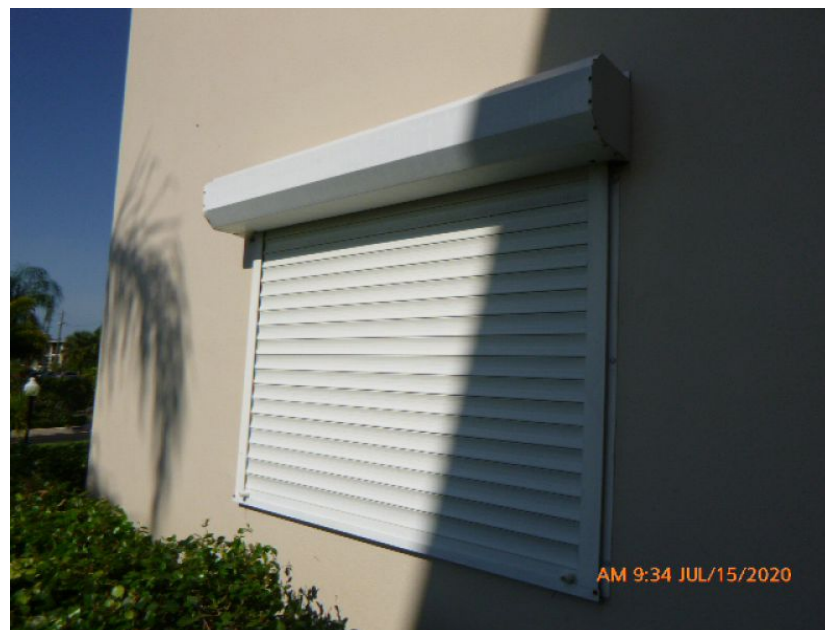
Non-Impact Rated Roll Down Shutter

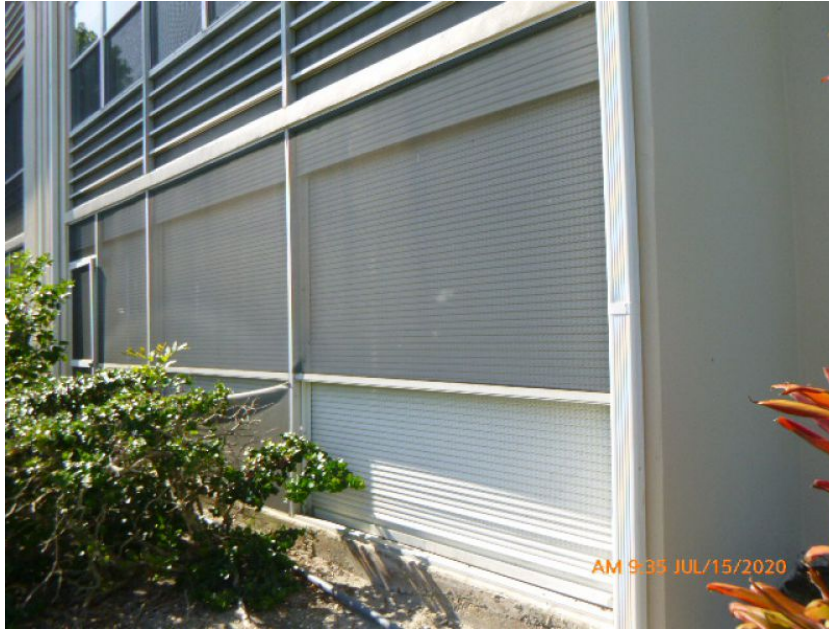
Non-Impact Rated Roll Down Shutter

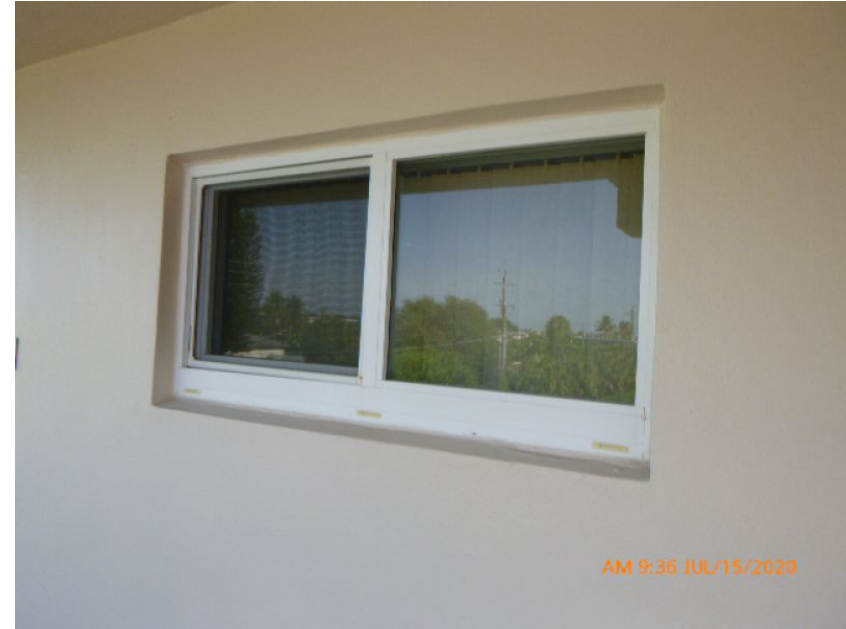
Impact Rated Window

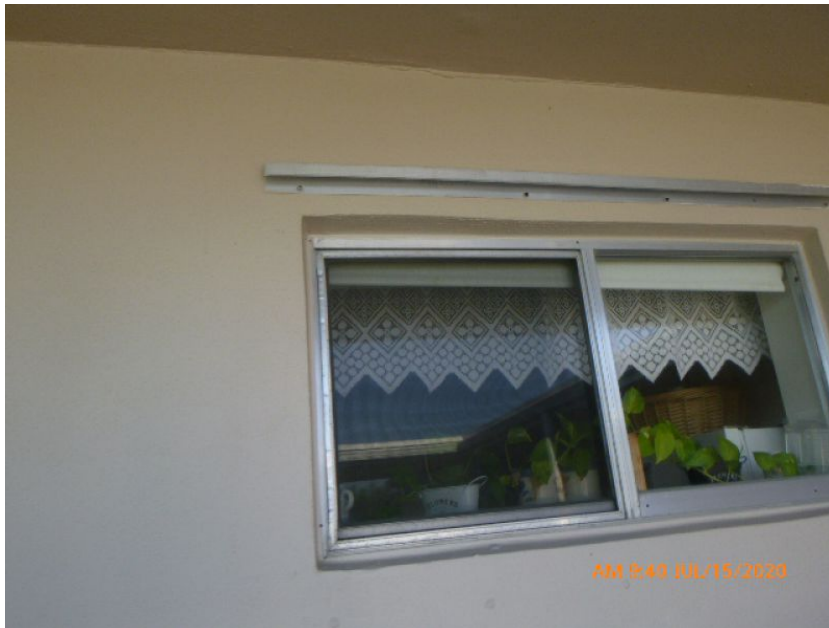
Panel Shutter - Unverified as Impact

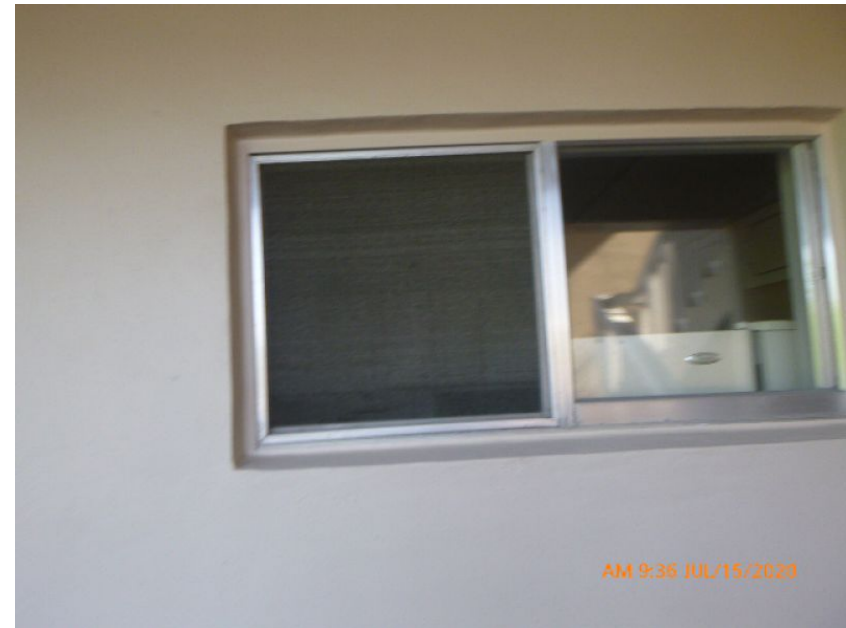
Unprotected Window
