Uniform Mitigation Verification Inspection Form

Inspection Date: 7/15/2020		
Owner Information		
Owner Name: Lake Clarke Gardens COA, Inc.		Contact Person:
Address: 2687 N. Garden Drive - Bldg #5		Home Phone: (561) 965-8487
City: Lake Worth	Zip: 33401	Work Phone:
County: Palm Beach		Cell Phone:
Insurance Company:		Policy #:
Year of Home: 1968	# of Stories: 3	Email: controller@lakeclarkegardens.com

Elevation Photos

2687 N. Garden Drive - Bldg #5

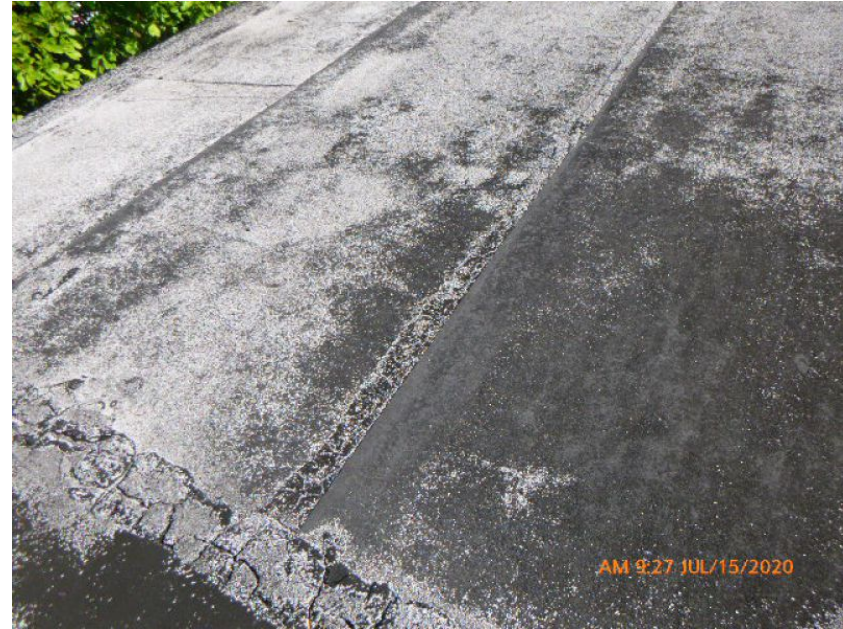
- ☐ A. All roof coverings listed above meet the FBC with a FBC or Miami-Dade Product Approval listing current at time of installation OR have a roofing permit application date on or after 3/1/02 OR the roof is original and built in 2004 or later.
- ☐ B. All roof coverings have a Miami-Dade Product Approval listing current at time of installation OR (for the HVHZ only) a roofing permit application after 9/1/1994 and before 3/1/2002 OR the roof is original and built in 1997 or later.
- ☐ C. One or more roof coverings do not meet the requirements of Answer "A" or "B".
- ☒ D. No roof coverings meet the requirements of Answer "A" or "B".

Built-Up/Rolled Asphalt Roof Covering

Roof Covering Replacement. Our report shows that at least a portion of your roof was permitted prior to the adoption of the latest building codes. As a result, the next time your roof is replaced, it will receive credit for having a roof covering and installation that meets the very latest Florida Building Code requirements.

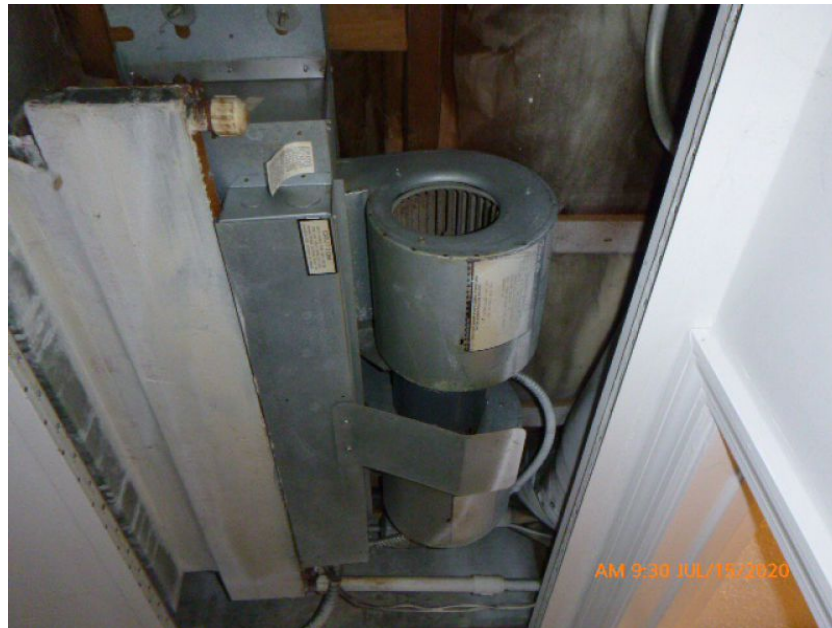
- ☐ D. Reinforced Concrete Roof Deck.
- ☐ E. Other: _____
- ☐ F. Unknown or unidentified.
- ☒ G. No attic access.

- ☐ E. Structural Anchor bolts structurally connected or reinforced concrete roof.
- ☐ F. Other: _____
- ☐ G. Unknown or unidentified
- ☒ H. No attic access

No Attic Access

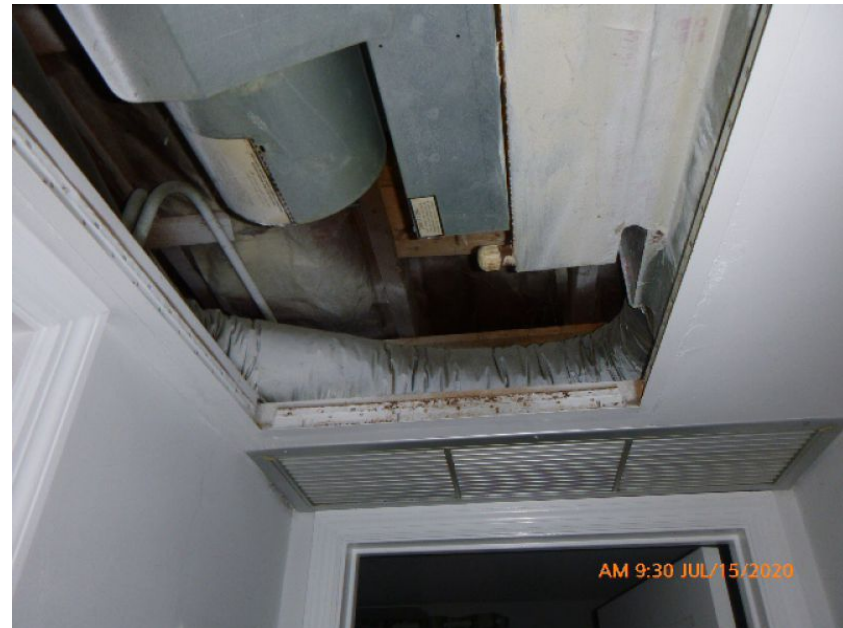
Attachment Unknown due to No Attic Access

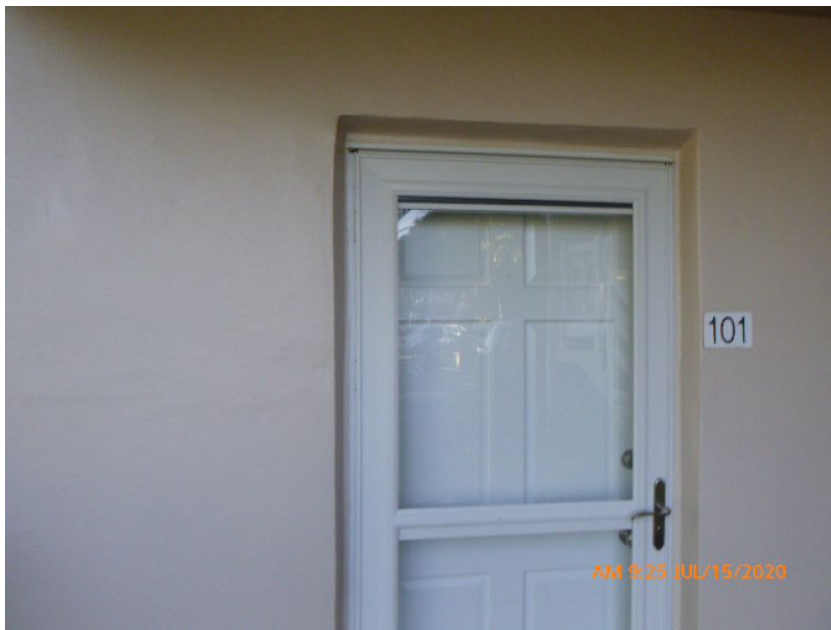
Unprotected Solid Entry Door

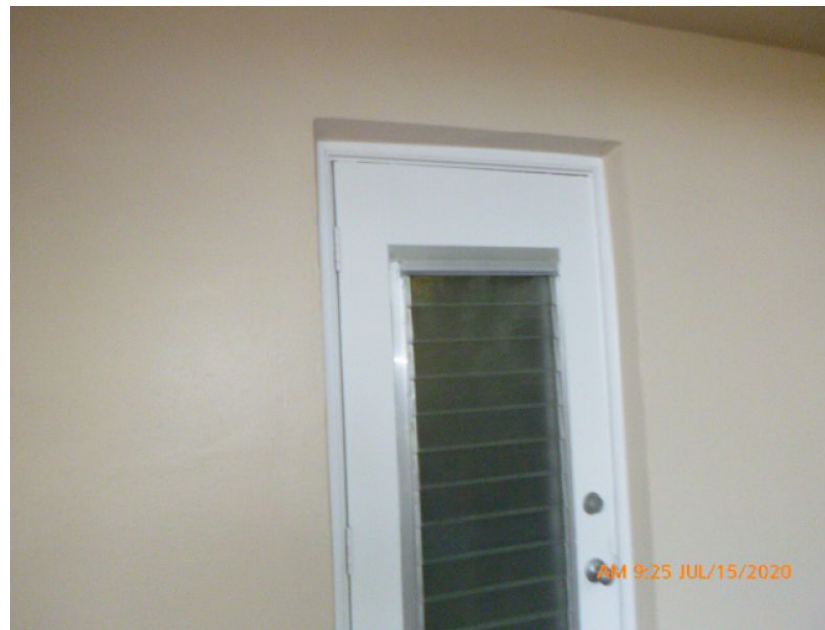
Unprotected Glazed Entry Door

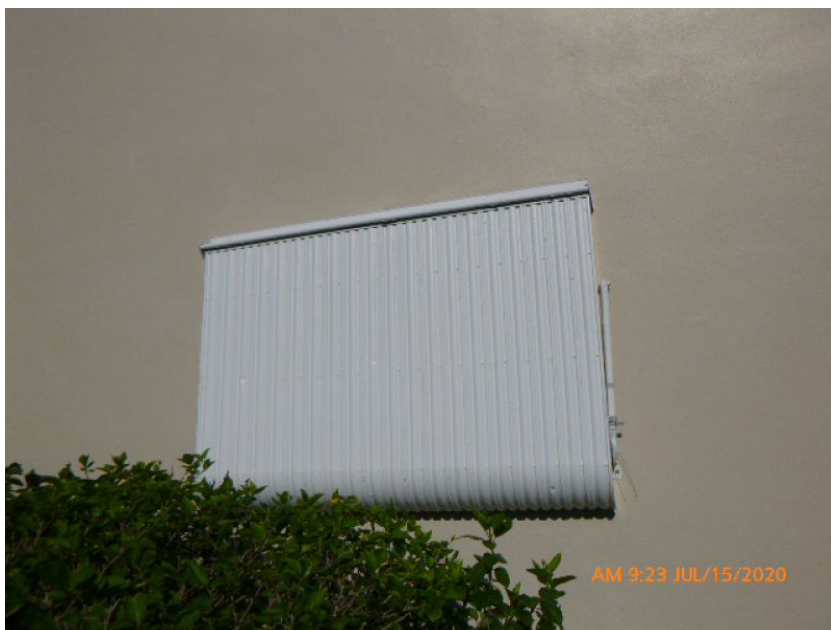
Non-Impact Rated Clamshell Awning Shutter

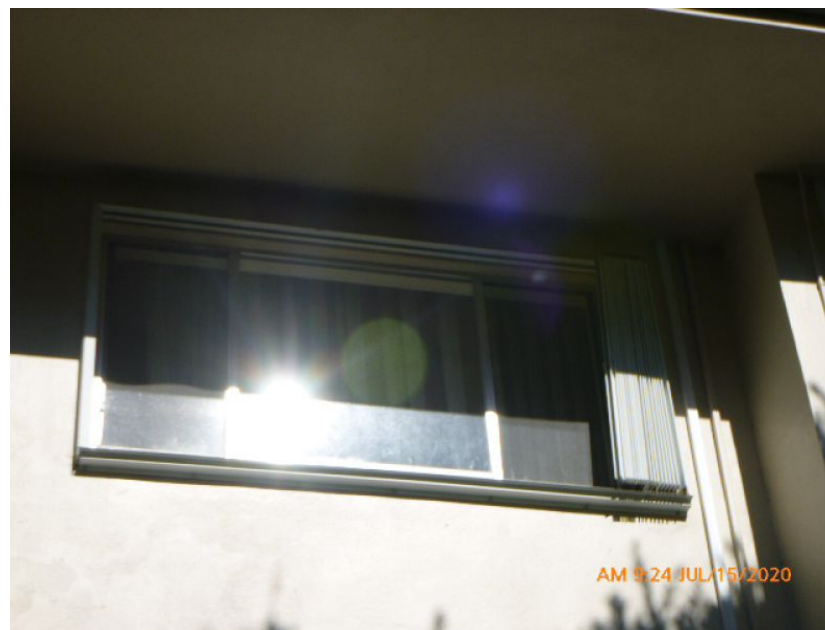
Non-Impact Rated Accordion Shutter

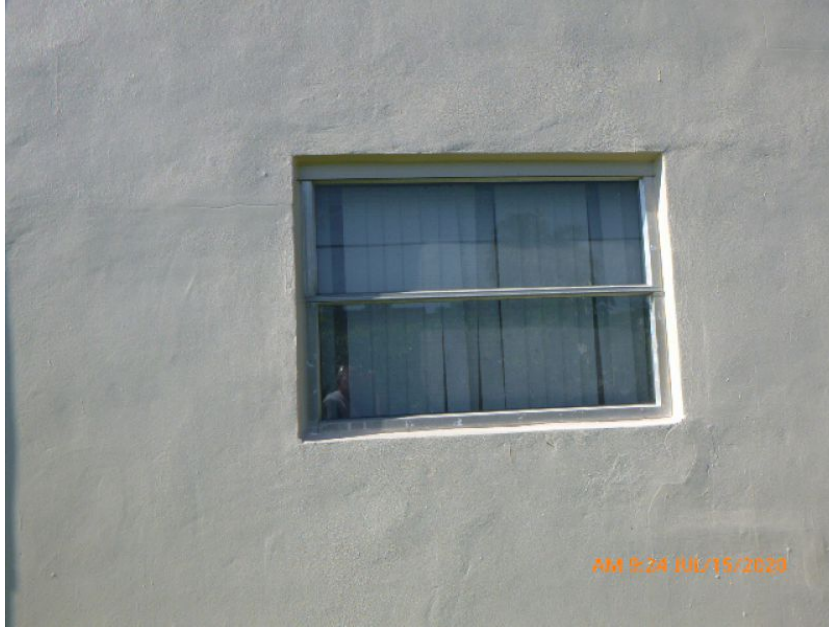
Unprotected Window

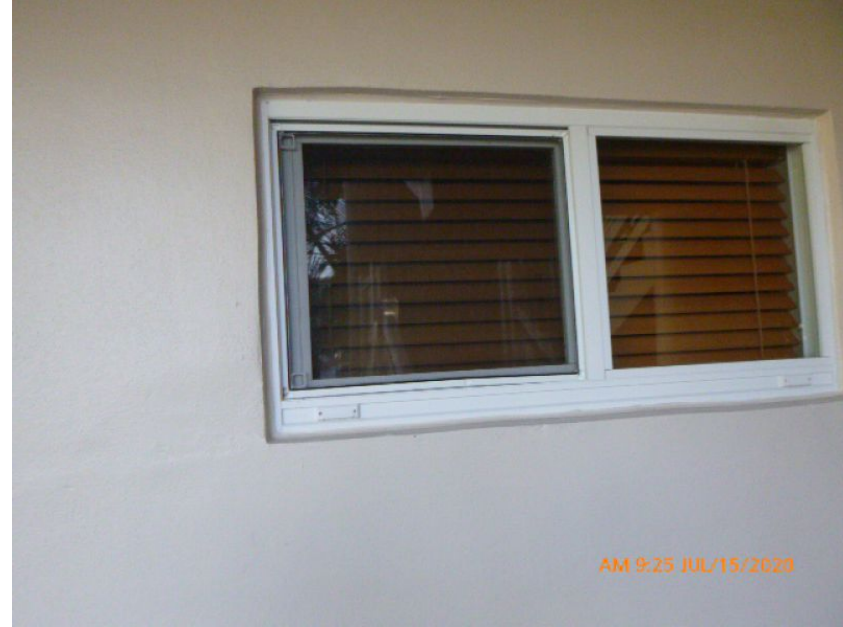
Impact Rated Window

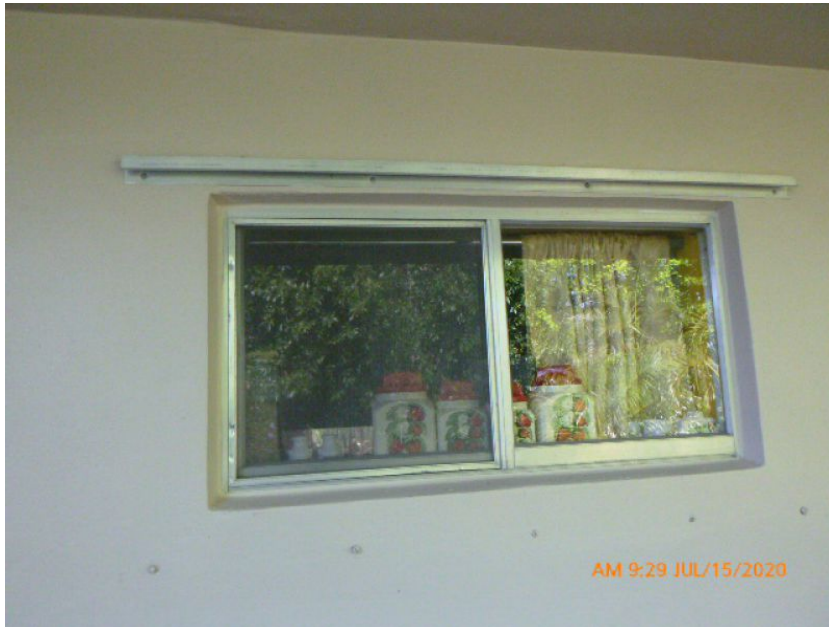
Panel Shutter - Unverified as Impact

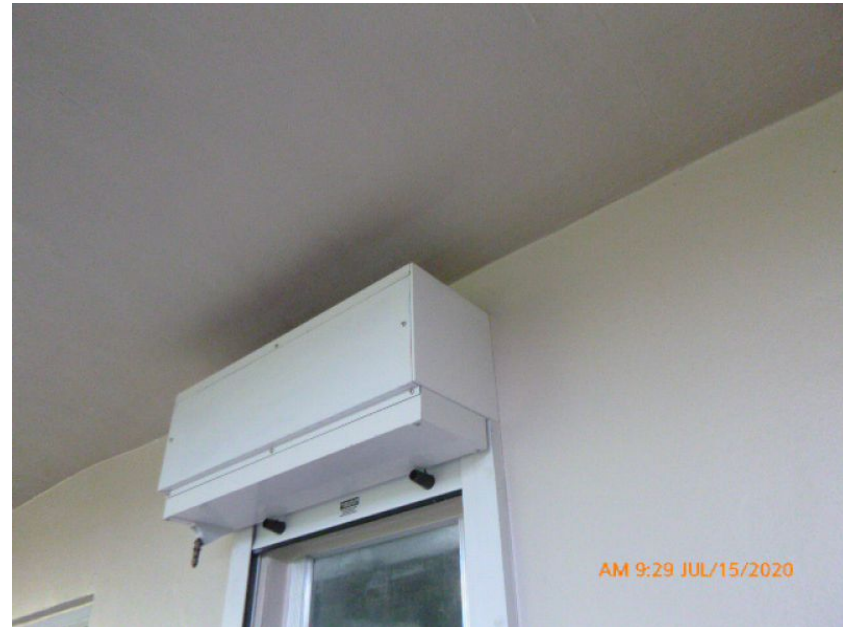
Impact Rated Rolldown Shutters

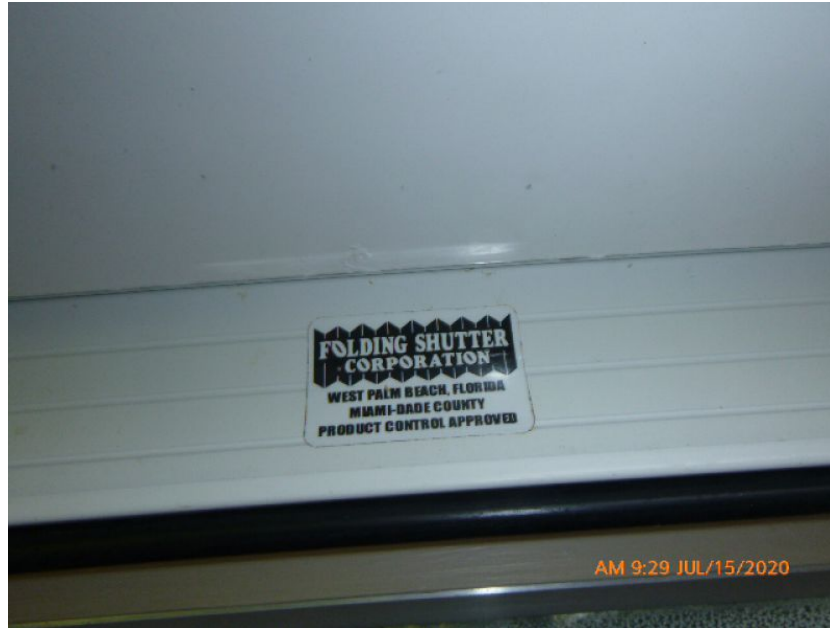
Impact Rated Rolldown Shutter Label
