Uniform Mitigation Verification Inspection Form

Inspection Date: 7/16/2020		
Owner Information		
Owner Name: Lake Clarke Gardens COA, Inc.		Contact Person:
Address: 2770 S. Garden Drive - Bldg #21		Home Phone: (561) 965-8487
City: Lake Worth	Zip: 33401	Work Phone:
County: Palm Beach		Cell Phone:
Insurance Company:		Policy #:
Year of Home: 1970	# of Stories: 3	Email: controller@lakeclarkegardens.com

Elevation Photos

2770 S. Garden Drive - Bldg #21

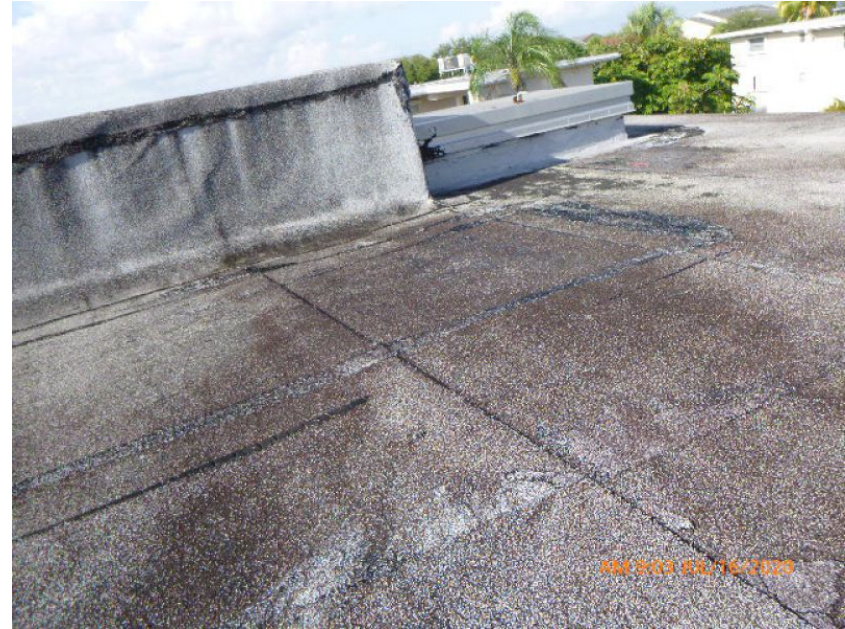
- ☐ A. All roof coverings listed above meet the FBC with a FBC or Miami-Dade Product Approval listing current at time of installation OR have a roofing permit application date on or after 3/1/02 OR the roof is original and built in 2004 or later.
- ☐ B. All roof coverings have a Miami-Dade Product Approval listing current at time of installation OR (for the HVHZ only) a roofing permit application after 9/1/1994 and before 3/1/2002 OR the roof is original and built in 1997 or later.
- ☐ C. One or more roof coverings do not meet the requirements of Answer "A" or "B".
- ☒ D. No roof coverings meet the requirements of Answer "A" or "B".

Built-Up/Rolled Asphalt Roof Covering

Roof Covering Replacement. Our report shows that at least a portion of your roof was permitted prior to the adoption of the latest building codes. As a result, the next time your roof is replaced, it will receive credit for having a roof covering and installation that meets the very latest Florida Building Code requirements.

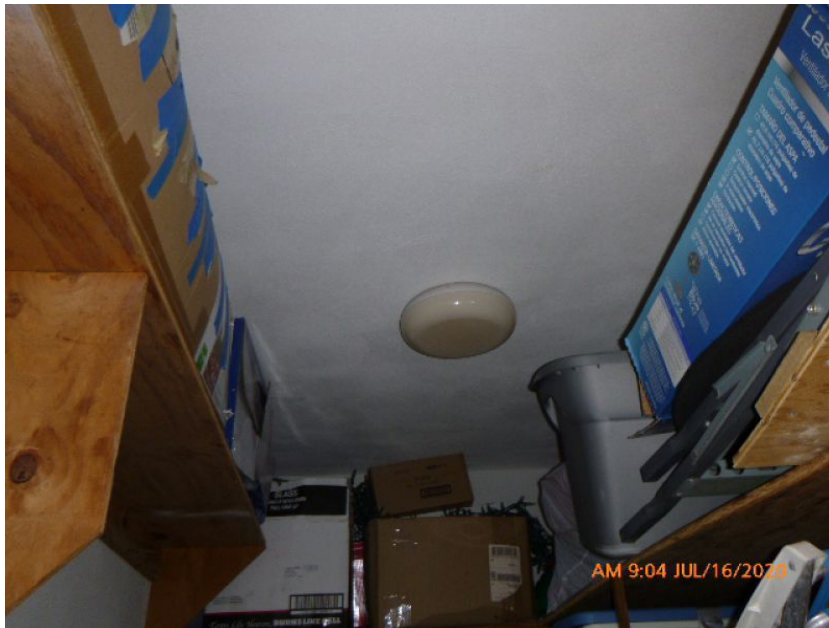
- ☐ D. Reinforced Concrete Roof Deck.
- ☐ E. Other: _____
- ☐ F. Unknown or unidentified.
- ☒ G. No attic access.

No Attic Access

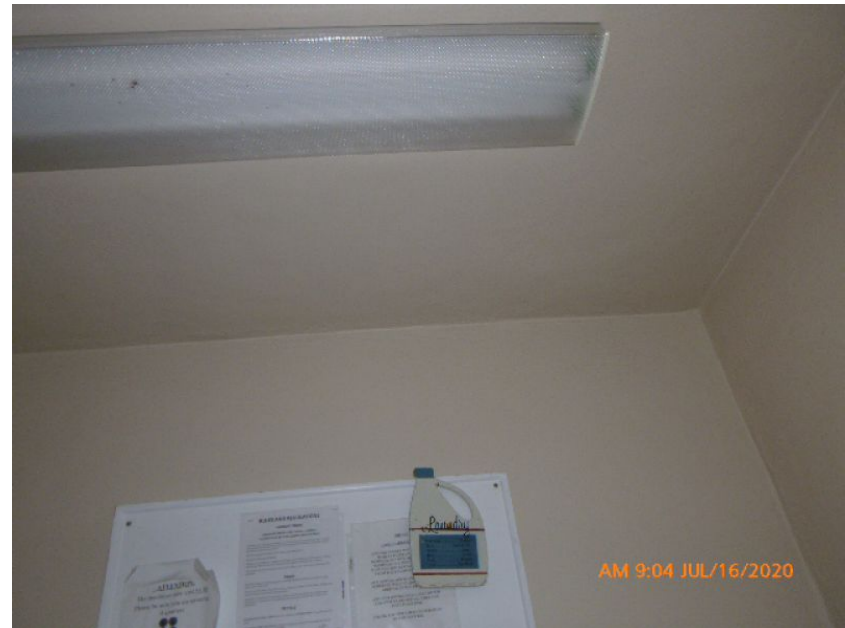
- ☐ E. Structural Anchor bolts structurally connected or reinforced concrete roof.
- ☐ F. Other: _____
- ☐ G. Unknown or unidentified
- ☒ H. No attic access

Attachment Unknown due to No Attic Access

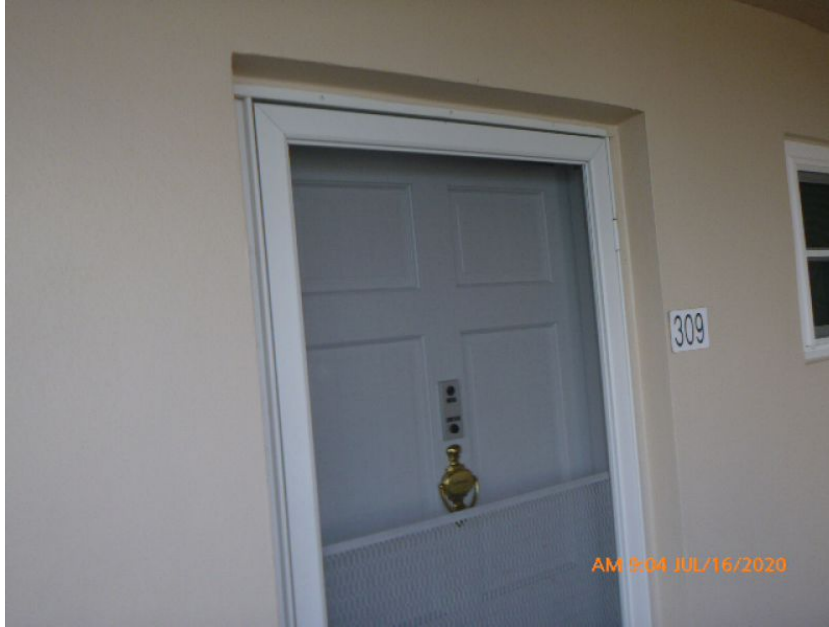
Unprotected Solid Entry Door

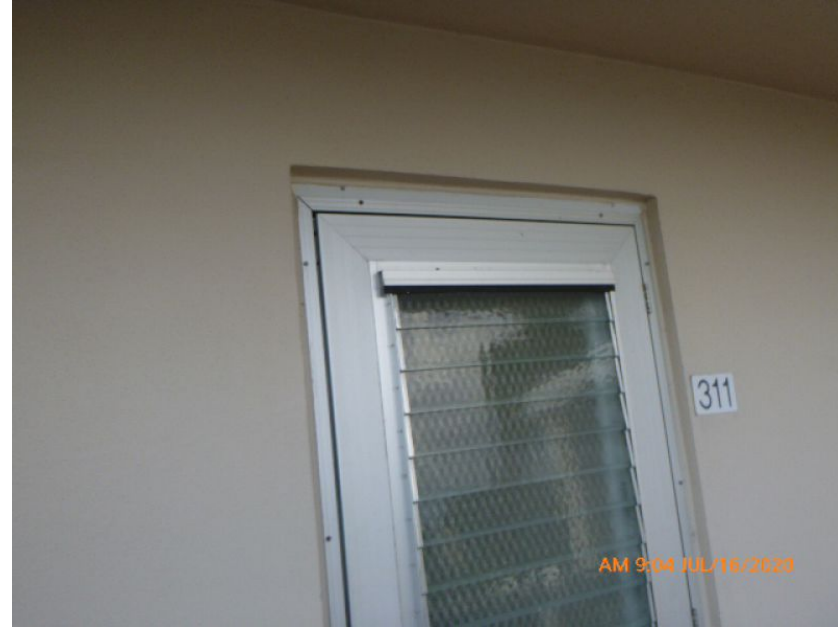
Unprotected Glazed Entry Door

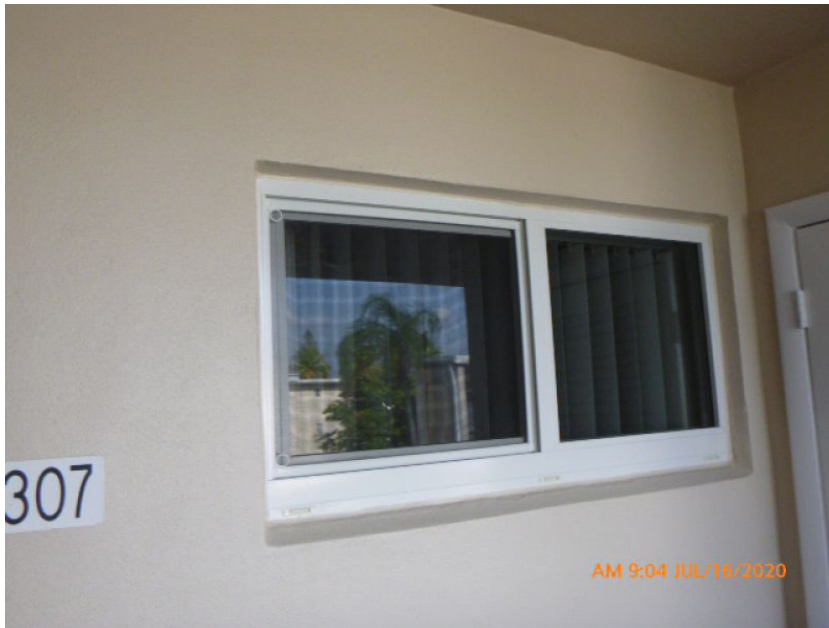
Impact Rated Window

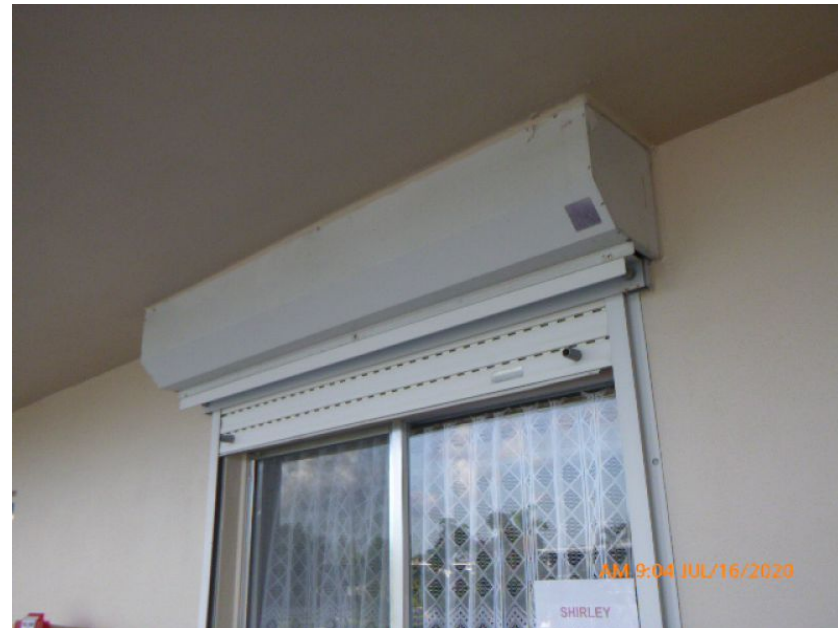
Rolldown Shutter - Unverified as Impact

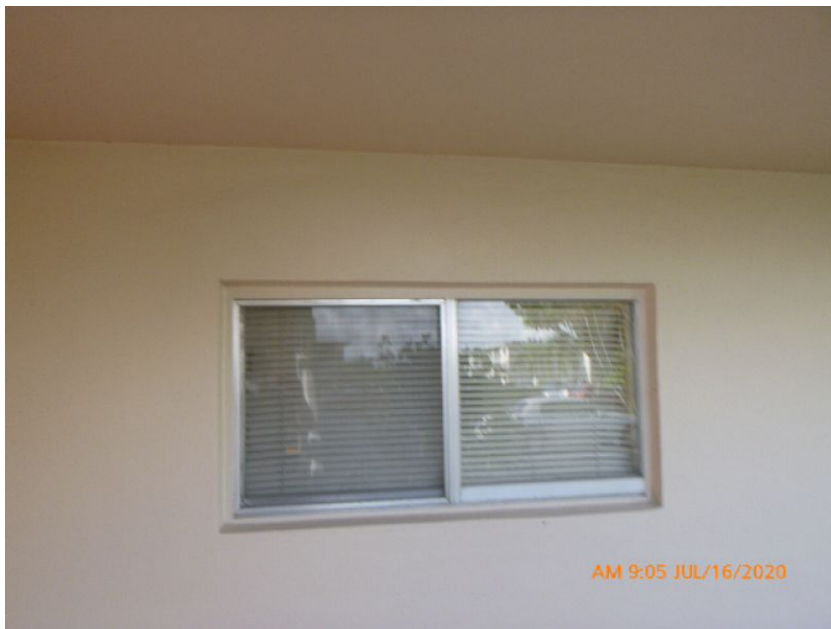
Unprotected Window

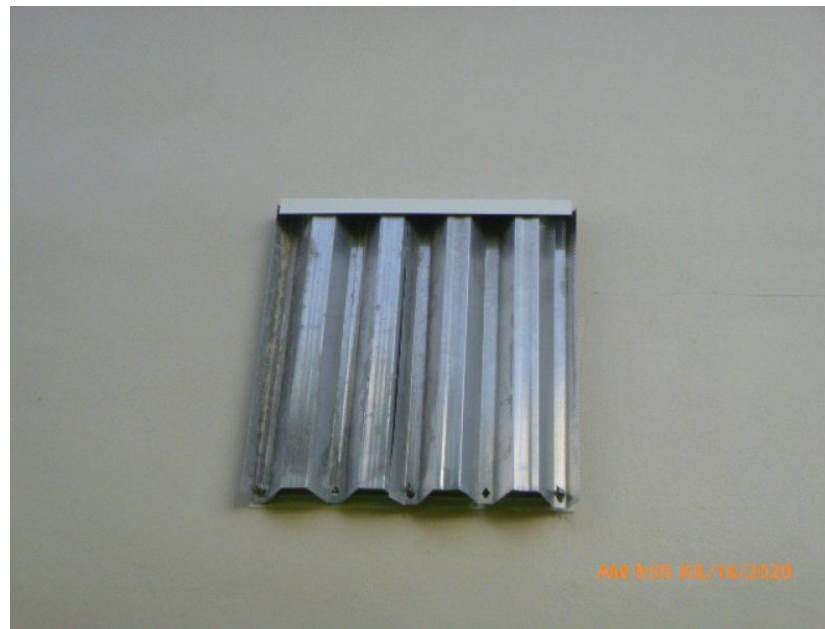
Non-Impact Rated Panel Shutters

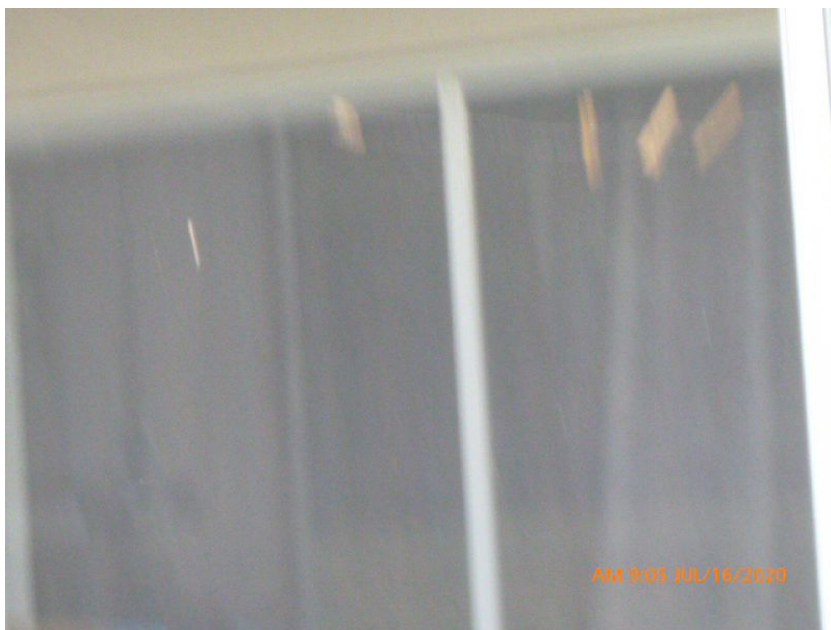
Unprotected Glazed Entry Door

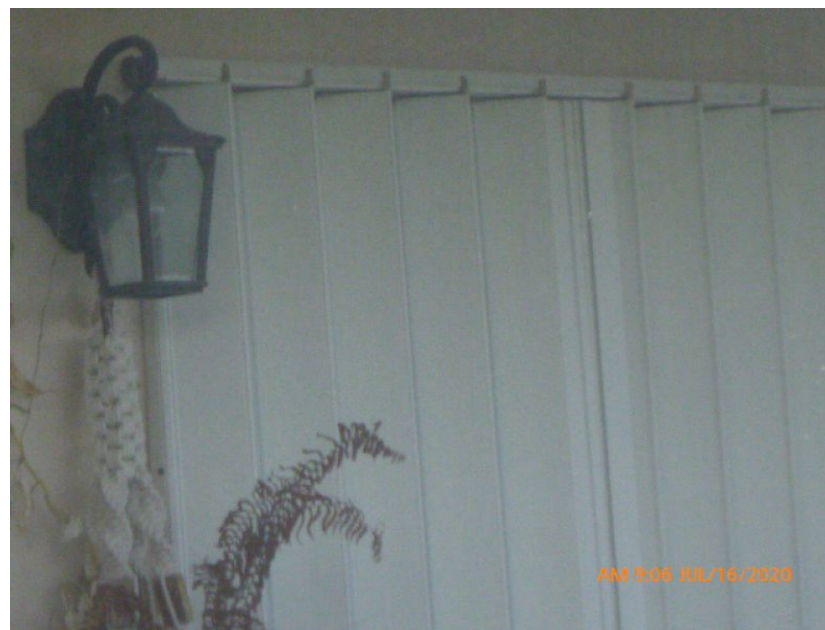
Non-Impact Rated Accordion Shutter

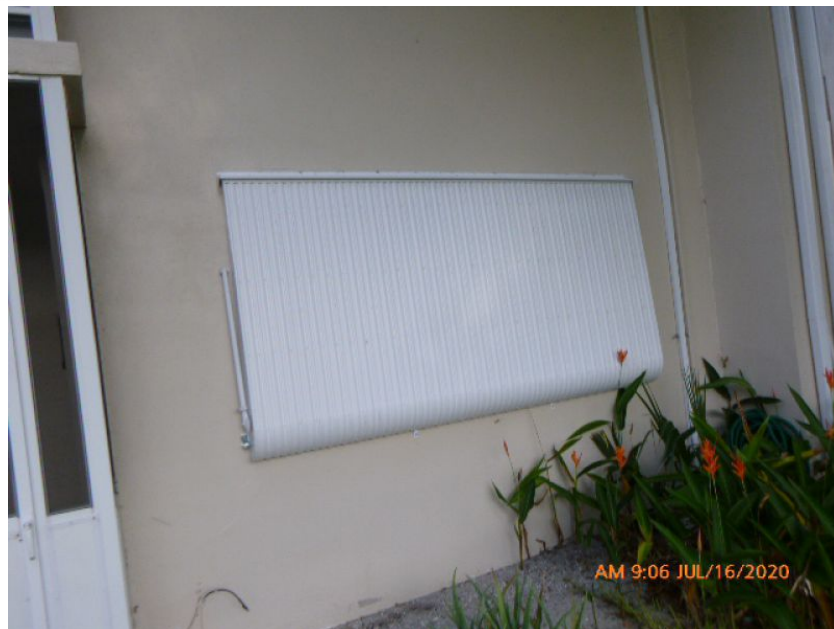
Non-Impact Rated Clamshell Awning Shutter

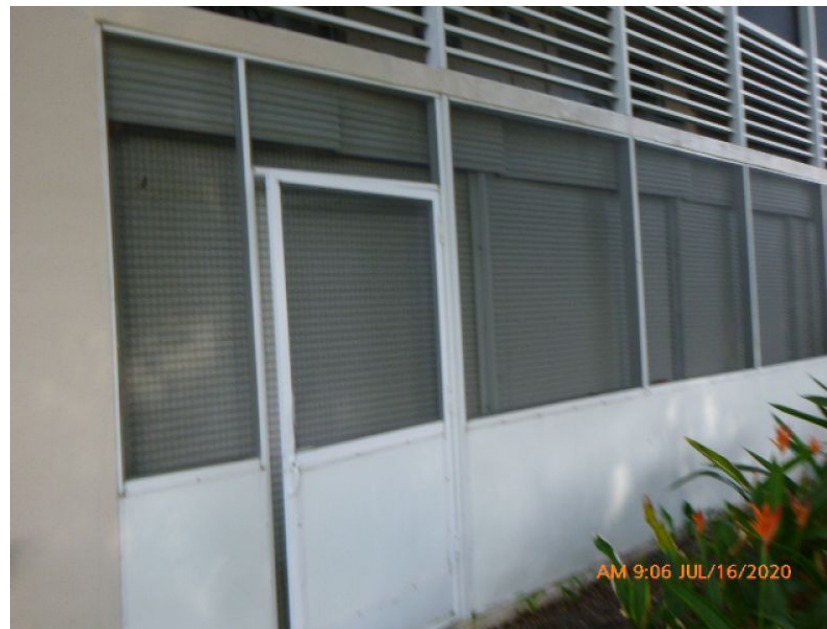
Non-Impact Rated Roll Down Shutter
