Uniform Mitigation Verification Inspection Form

Inspection Date: 7/16/2020						
Owner Information						
Owner Name: Lake Clarke Garden	Contact Person:					
Address: 2724 S. Garden Drive - H	3ldg #15	Home Phone: (561) 965-8487				
City: Lake Worth	Zip: 33401	Work Phone:				
County: Palm Beach		Cell Phone:				
Insurance Company:	·	Policy #:				
Year of Home: 1969	# of Stories: 3	Email: controller@lakeclarkegardens.com

Inspectors Initials BD Property Address 2724 S. Garden Drive - Bldg #15 Lake Worth, FL 33401 DMI: 1299963

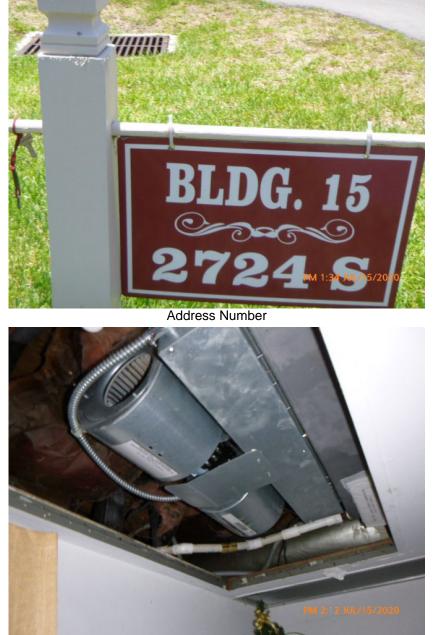
Attachment Unknown due to No Attic Access

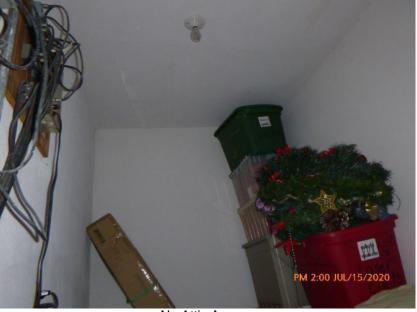
No Attic Access

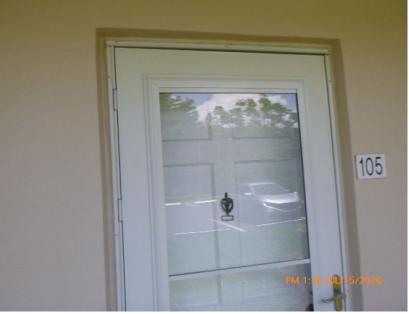
Unprotected Solid Entry Door

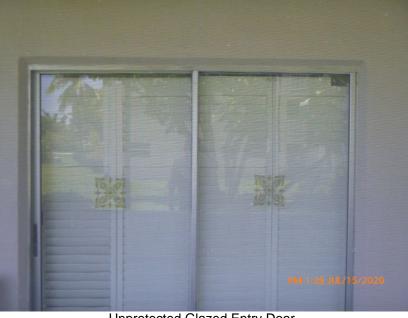
Unprotected Glazed Entry Door

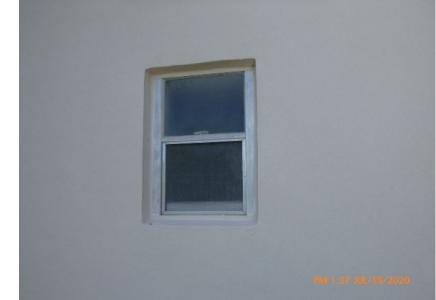
Unprotected Window

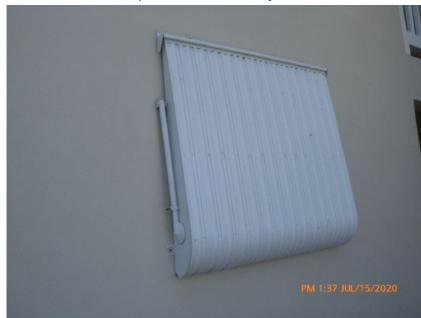
Non-Impact Rated Clamshell Awning Shutter

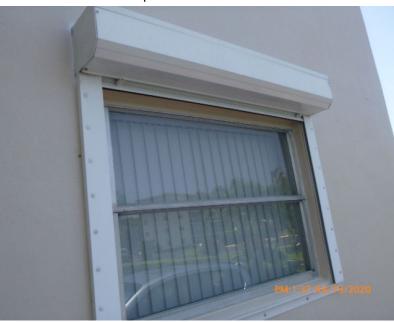
Rolldown Shutter - Unverified as Impact

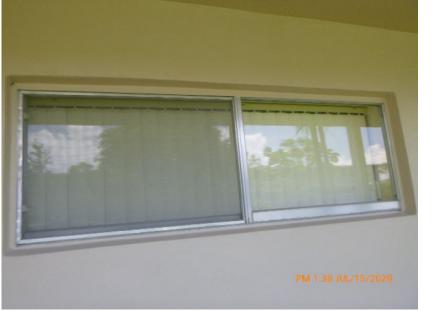
Unprotected Window

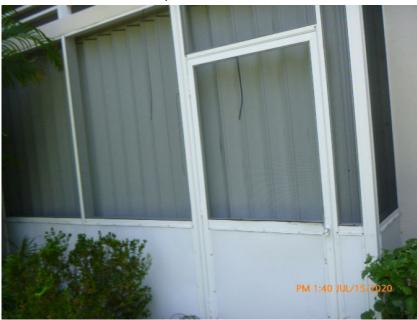
Accordion Shutter - Unverified as Impact

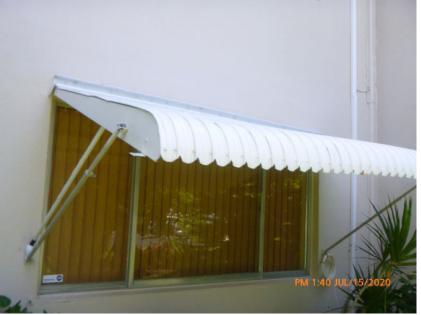
Non-Impact Rated Clamshell Awning Shutter

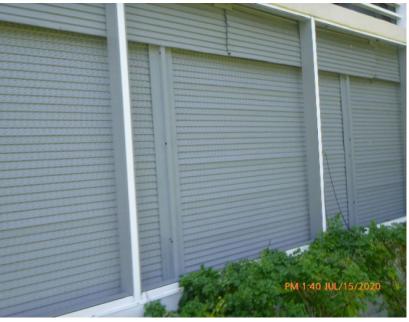
Non-Impact Rated Roll Down Shutter

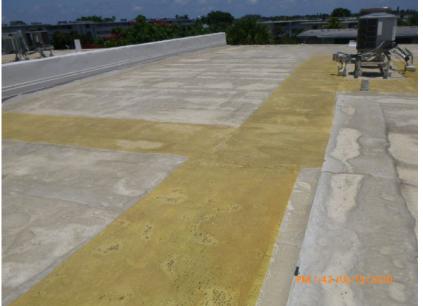
2.1 Roof Covering Type:	Permit Application Date	FBC or MDC Product Approval #	Year of Original Installation or Replacement	No Information Provided for Compliance
1. Asphalt/Fiberglass Shingle	//			
2. Concrete/Clay Tile	//			
3. Metal	//			
4. Built Up	//			
5. Membrane	05/22/2019	Prmt#: b2019-015898-0000		
6. Other	//

Membrane Roof Covering

Secondary Water Resistant ("SWR") Barrier. Our report indicates that your roof does not currently have 1) strips or sheets of a self-adhering modified bitumen barrier attached directly to the top of the roof deck sheathing, or 2) a high-strength, closed-cell foam adhesive barrier on all the seams throughout your attic. The presence of either of these types of valid SWR barriers provides increased protection against water intrusion. Before having your roof replaced, be sure to inquire of your roofing professional regarding the cost of these options.
