Uniform Mitigation Verification Inspection Form

Inspection Date: 7/16/2020		
Owner Information		
Owner Name: Lake Clarke Gardens COA, Inc.		Contact Person:
Address: 2856 S. Garden Drive - Bldg #23		Home Phone: (561) 965-8487
City: Lake Worth	Zip: 33401	Work Phone:
County: Palm Beach		Cell Phone:
Insurance Company:		Policy #:
Year of Home: 1970	# of Stories: 3	Email: controller@lakeclarkegardens.com

Inspectors Initials BD **Property Address** 2856 S. Garden Drive - Bldg #23 Lake Worth, FL 33401 DMI: 1299970

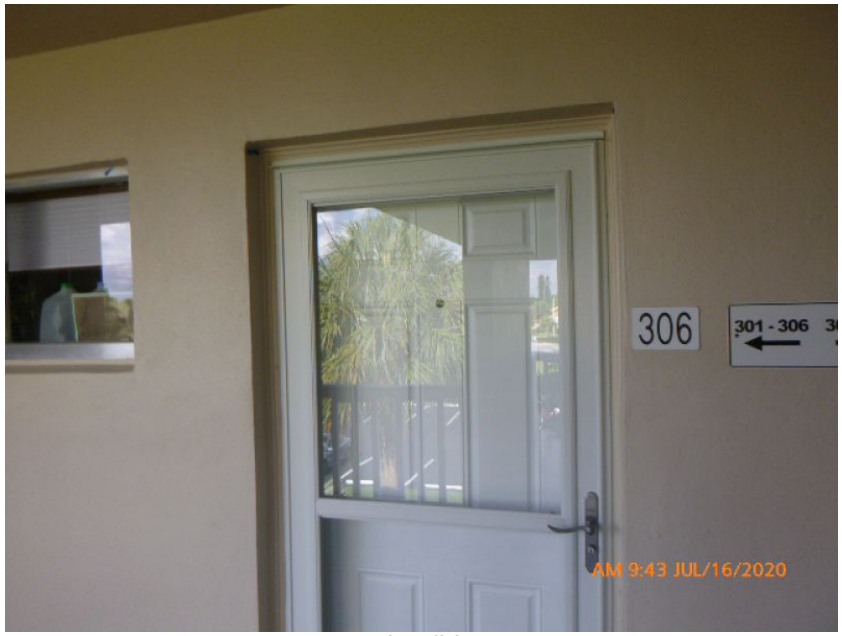
Unprotected Solid Entry Door

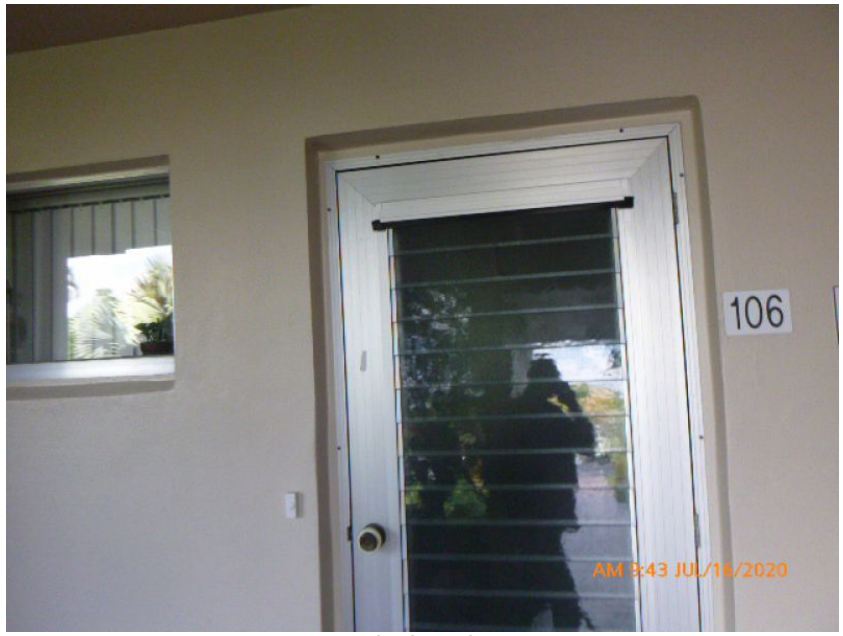
Unprotected Glazed Entry Door

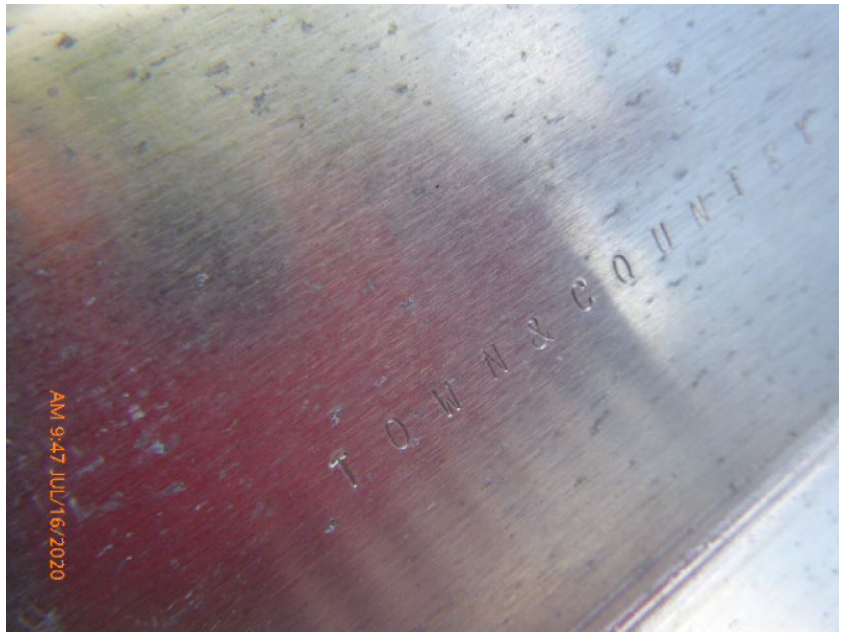
Impact Rated Panel Shutter Label
