Uniform Mitigation Verification Inspection Form

Inspection Date: 7/16/2020		
Owner Information		
Owner Name: Lake Clarke Gardens COA, Inc.		Contact Person:
Address: 2991 S. Garden Drive - Bldg #20b		Home Phone: (561) 965-8487
City: Lake Worth	Zip: 33401	Work Phone:
County: Palm Beach		Cell Phone:
Insurance Company:		Policy #:
Year of Home: 1972	# of Stories: 3	Email: controller@lakeclarkegardens.com

Inspectors Initials BD **Property Address** 2991 S. Garden Drive - Bldg #20b Lake Worth, FL 33401 DMI: 1299974

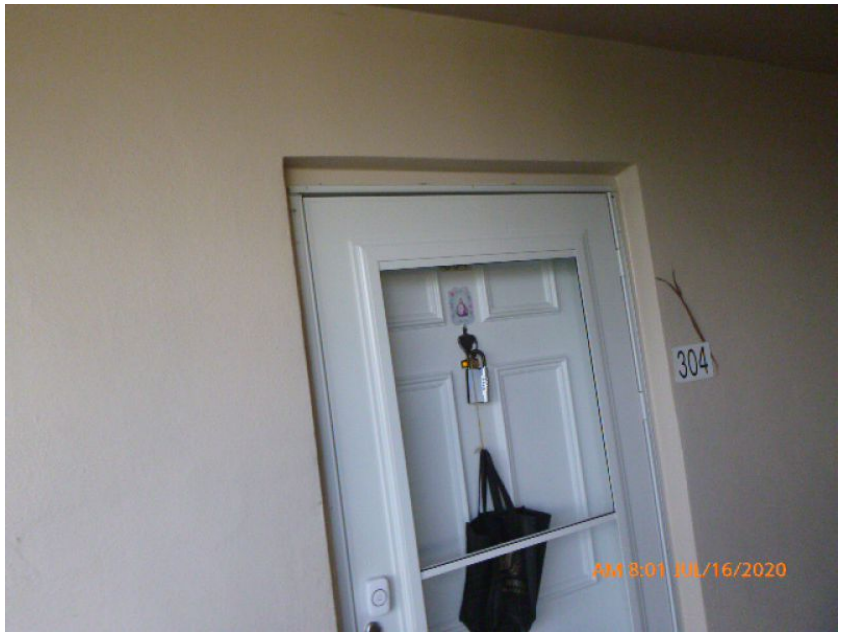
Unprotected Solid Entry Door

Unprotected Glazed Entry Door

Panel Shutter - Unverified as Impact

Unprotected Window
